**ROOF:**

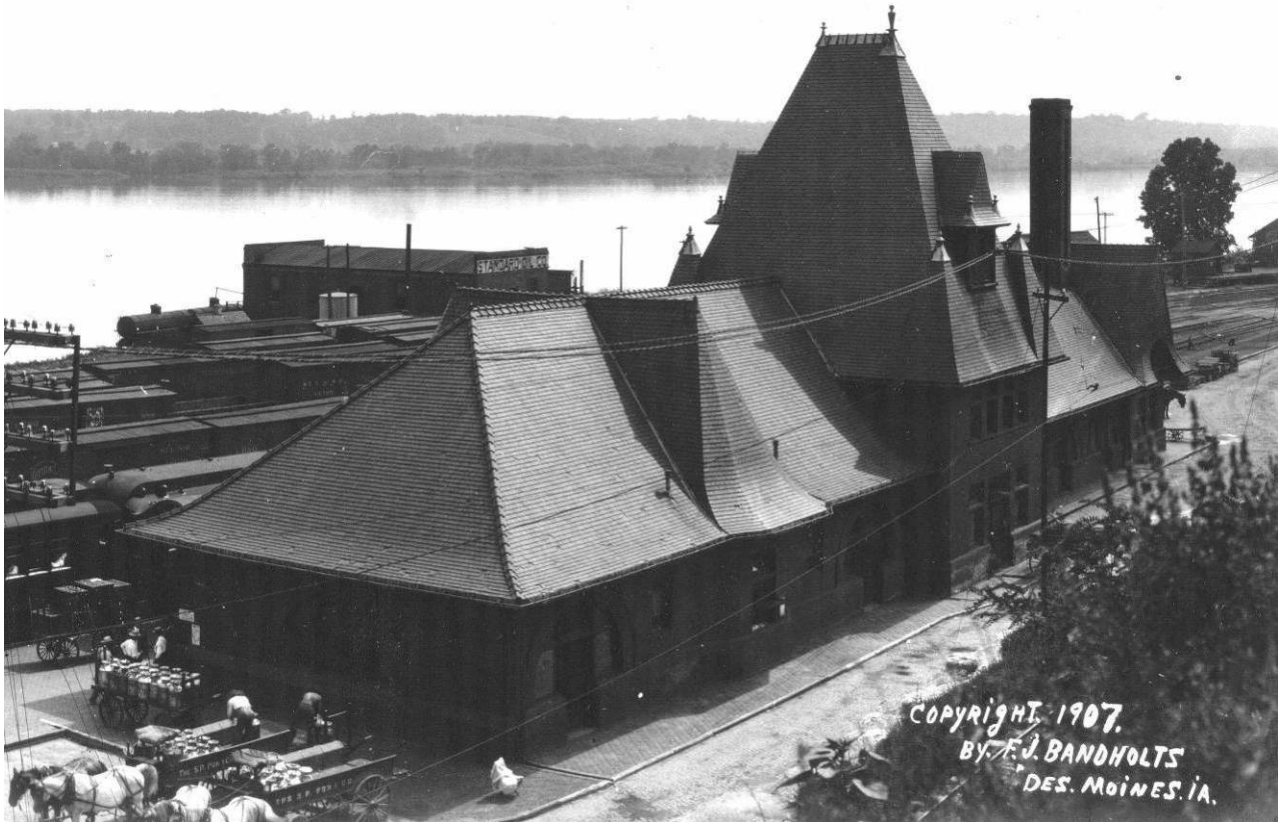
The Bandholtz panorama also shows nearly 80 missing or broken field tiles and one missing hip tile. More than half of these are missing from the waiting room roof, concentrated at the flared eaves. This is puzzling since clay tile is usually a century-plus roof and it was only sixteen years old in this image. Although the damage may be attributed to a recent storm and not yet repaired, it may also provide some insight on the original roof's performance with the 3/8" flat slab tile. Several installation factors could account for the missing tiles. Some nails may have been "driven-home" (nailed too deep) which cracked various tiles and caused them to slip. Moreover, the same nails may have been employed everywhere even though longer nails are required at the transition into the flared eaves. With poor "purchase," short nails would have pulled loose from high winds, train vibrations, etc. It is also possible that iron nails were used in lieu of copper nails and began to corrode and fail in 1907. However, these are merely speculations and the concentration of missing tiles at the eaves may simply point to the weathering performance of the original tiles and their resistance to: a) hail damage (which would tend to increase as the roof pitch diminishes at the eaves, or b) ice damming in the gutters that dislodged tiles at the eaves (or a combination of both).

**Fig 14. The Depot's original roofline and all of its decorative accessories.**

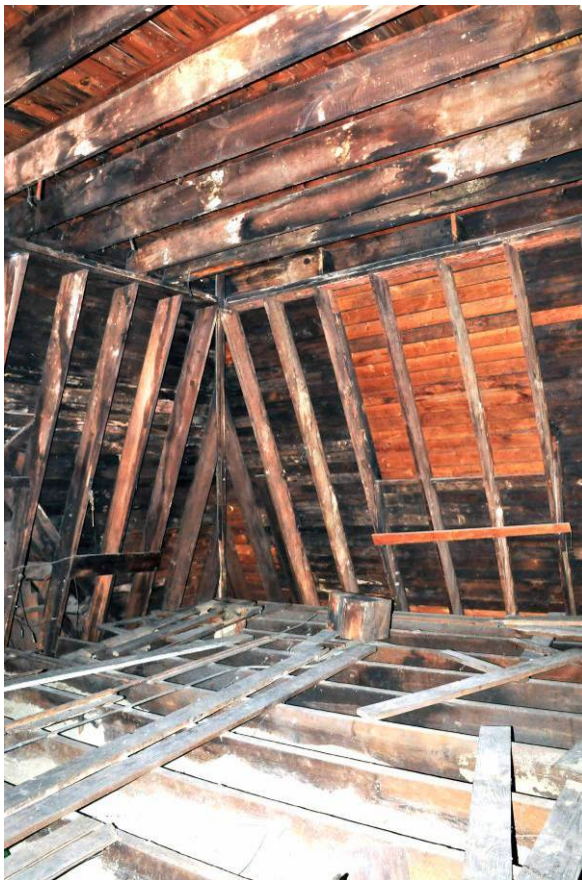
The upper hip roof is framed with 2" x 12" rafters spaced 24" on-center and decked solid with original ¾" x 6" tongue & groove (T&G) decking. The rafters are sound despite roof leaks and surface charring in the west corner from a lightning strike on July 8, 1937 that caused a fire. An article at the time noted "*officials at the Union station say that when the lightning struck the building they could hear several tile rip from the roof and fall to the pavement below.*"<sup>37</sup> The first architectural accents to be lost on the Depot roof were the copper ridge and finials at the top of the upper hip roof but contemporary descriptions of the lightning strike indicate the bolt entered lower on the hip through a phone line. The ridge and finials do appear to be missing in a poor quality snapshot of the MTZ calling at Keokuk between 1935 and 1945. Until very recently, many believed the upper hip roof was removed as a result of the lightning strike and fire. This assumption was made in both of the National Register nominations in 1994 and again in 2012. However, a 1947 photo recently rediscovered reveals the 1937 date was erroneous since the soaring clay tile roof is still there [Fig 9.]. The Depot is classified as a moderate-to-severe risk for lightning strikes according to National Fire Protection Agency standards and properly grounded lightning protection should be included in the reconstruction of the upper hip roof.

In speculation, the roof may have been replaced during the most significant interior remodeling in 1948-1949 (based on CB&Q remodeling drawings); this would fall into line with the photographic record. Future research may eventually determine the actual date the roof was altered and the clay tiles were removed—they probably occurred simultaneously. The resulting low-slope roof that replaced the upper hip peak is heavily framed with 2" x 14" and larger rafters salvaged from the upper roof portion that was removed [Fig 16.].

Fig 16. Roof framing in upper hip roof.

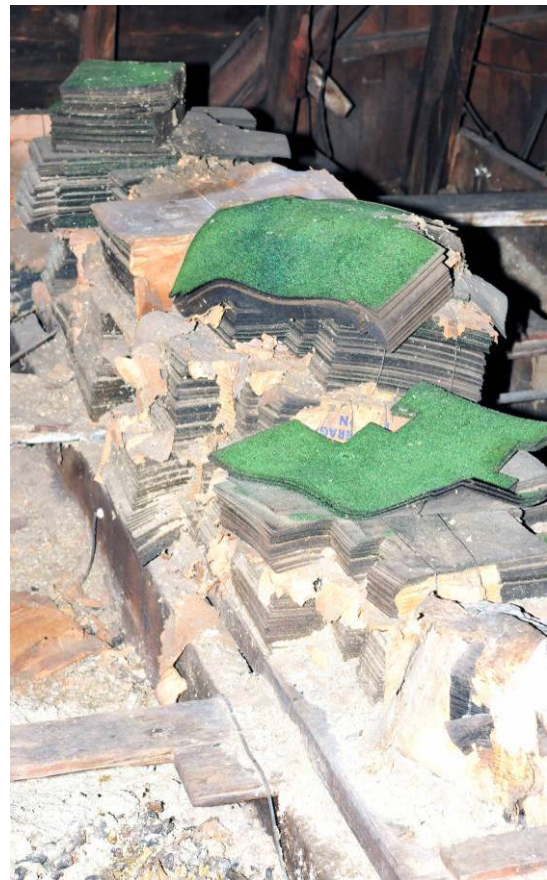
Bundles of asphalt shingle were left in the attic from circa 1950 [Fig 17.]. These shingles, along with other debris in the attics, create unnecessary point-loads on the ceiling structure and provide fuel for a fire. Any and all loose debris in the attics should be removed.

Fig 17. Stockpile of asphalt shingles.

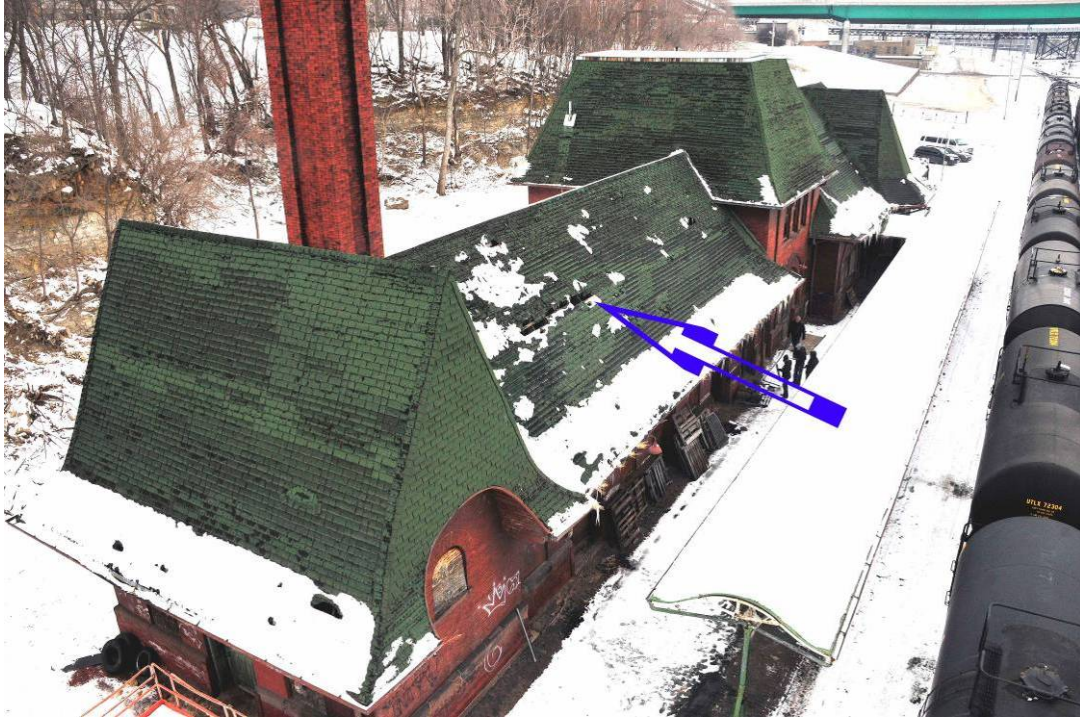
The roof over the downriver gable that covers the freight room will require the most extensive repairs and reinforcement. This roof section was missing shingles for many years resulting in rotted decking, rafters and purlins [Fig 18 & 19]. This even caused the tongue and groove ceiling below to pull loose from the ceiling joists in the far south freight room.

Fig 18. Aerial view of the holes in the roof observed in January 2011.

The roof rafters must be inspected more closely around the former gaping holes on the riverside slope, especially at their bearing point on the top plate, to determine the full extent of repairs and reinforcement required. The primary structural members of the trusses and purlins were found to be sound during the engineer's survey with the exception of isolated damage observed in a single purlin on the north slope of the downriver roof attributable to flashing concerns that caused water to wick into the end grain (above conductor's equipment room) [Figs 20. & 21.].

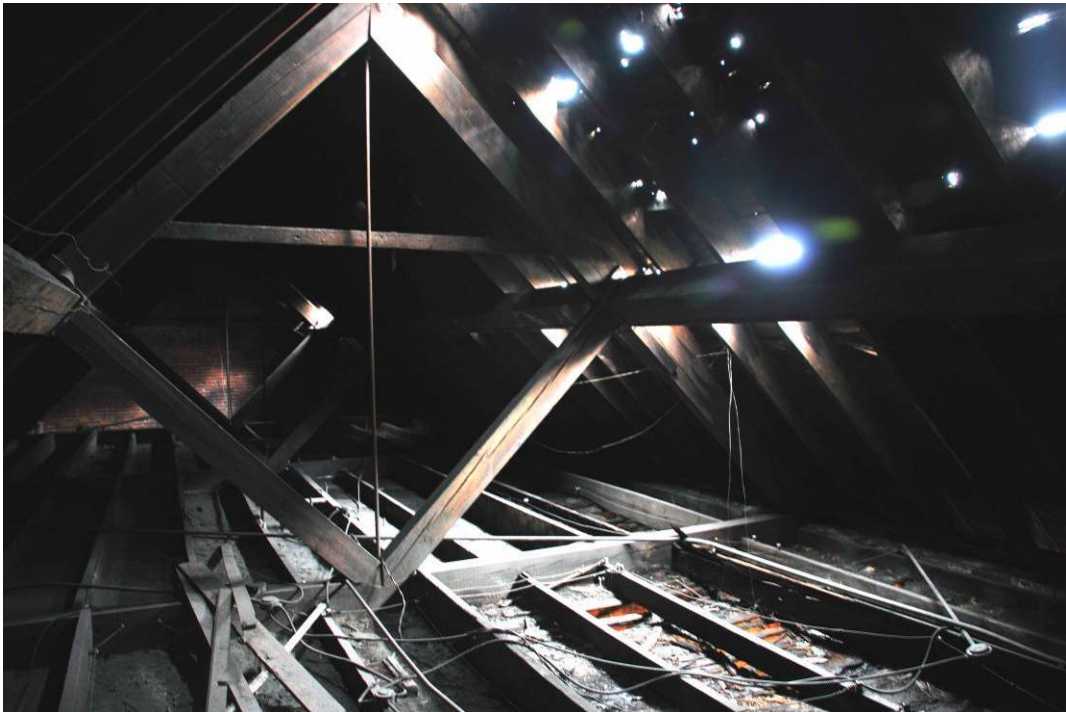
Fig 19. Holes in the riverside slope of the freight room roof (January 2011).

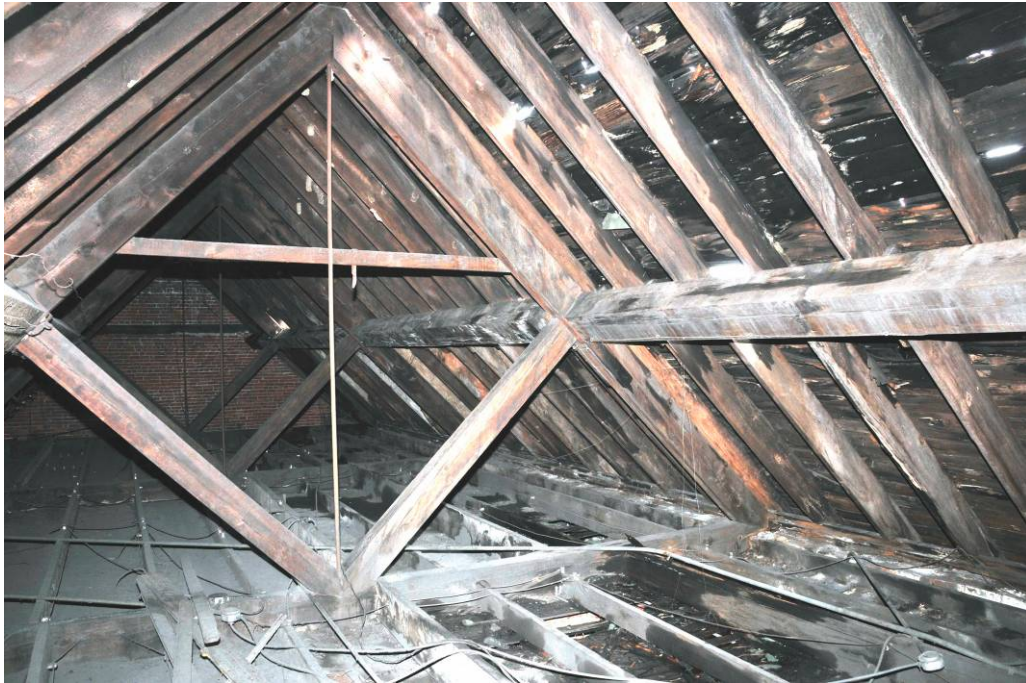
Fig 20. View upriver of riverside slope roof framing over the freight rooms.

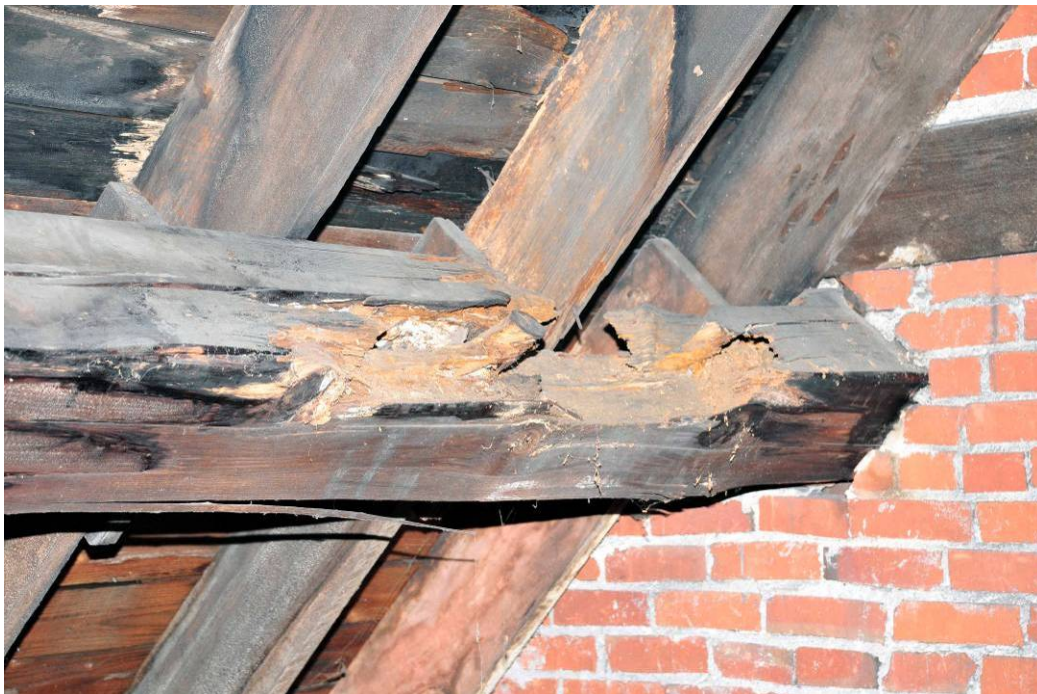
Fig 21. A rotted purlin on the north slope of the downriver roof at the two-story wall.

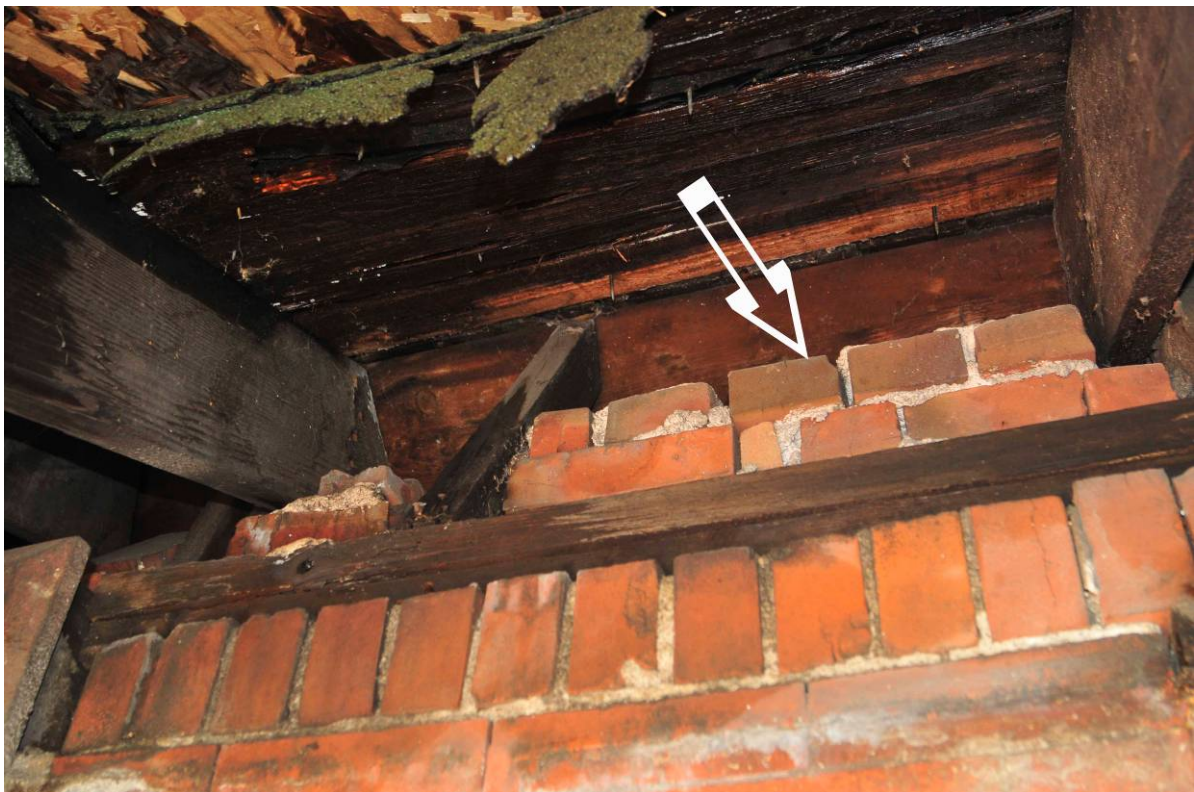
A curious construction detail is found inside the eaves around the waiting room. Here, one wythe of bricks set in lime mortar is stacked atop the wooden top plate of the wall [**Fig 26.**]. Additional clues for their role may be revealed when the roof is torn off and the eaves are reconstructed. However, they are not load-bearing and the only possible rationale determined at this time is that they were left as a makeshift fire-stop between the rafters. They are a variation of a Chicago masonry wall construction called “corbelling” that was (more effectively) employed as a fire-stop.<sup>38</sup> The KUD top-plate bricks are not contiguous and provide virtually no protection and do not occur at the upper hip roof eave or downriver roof eave. If during reconstruction, these bricks are deemed non-essential, any matching face brick should be removed and stockpiled for the exposed masonry wall repairs required below the eaves. If an essential role is determined for these bricks upon further investigation, any historic face brick can still be salvaged and replaced with new common brick since all masonry repairs above the eaves will remain concealed.

**Fig 26.** Face bricks atop the wood top-plate can be salvaged for visible repairs below the eaves.
