## INTERIOR

### Waiting Room

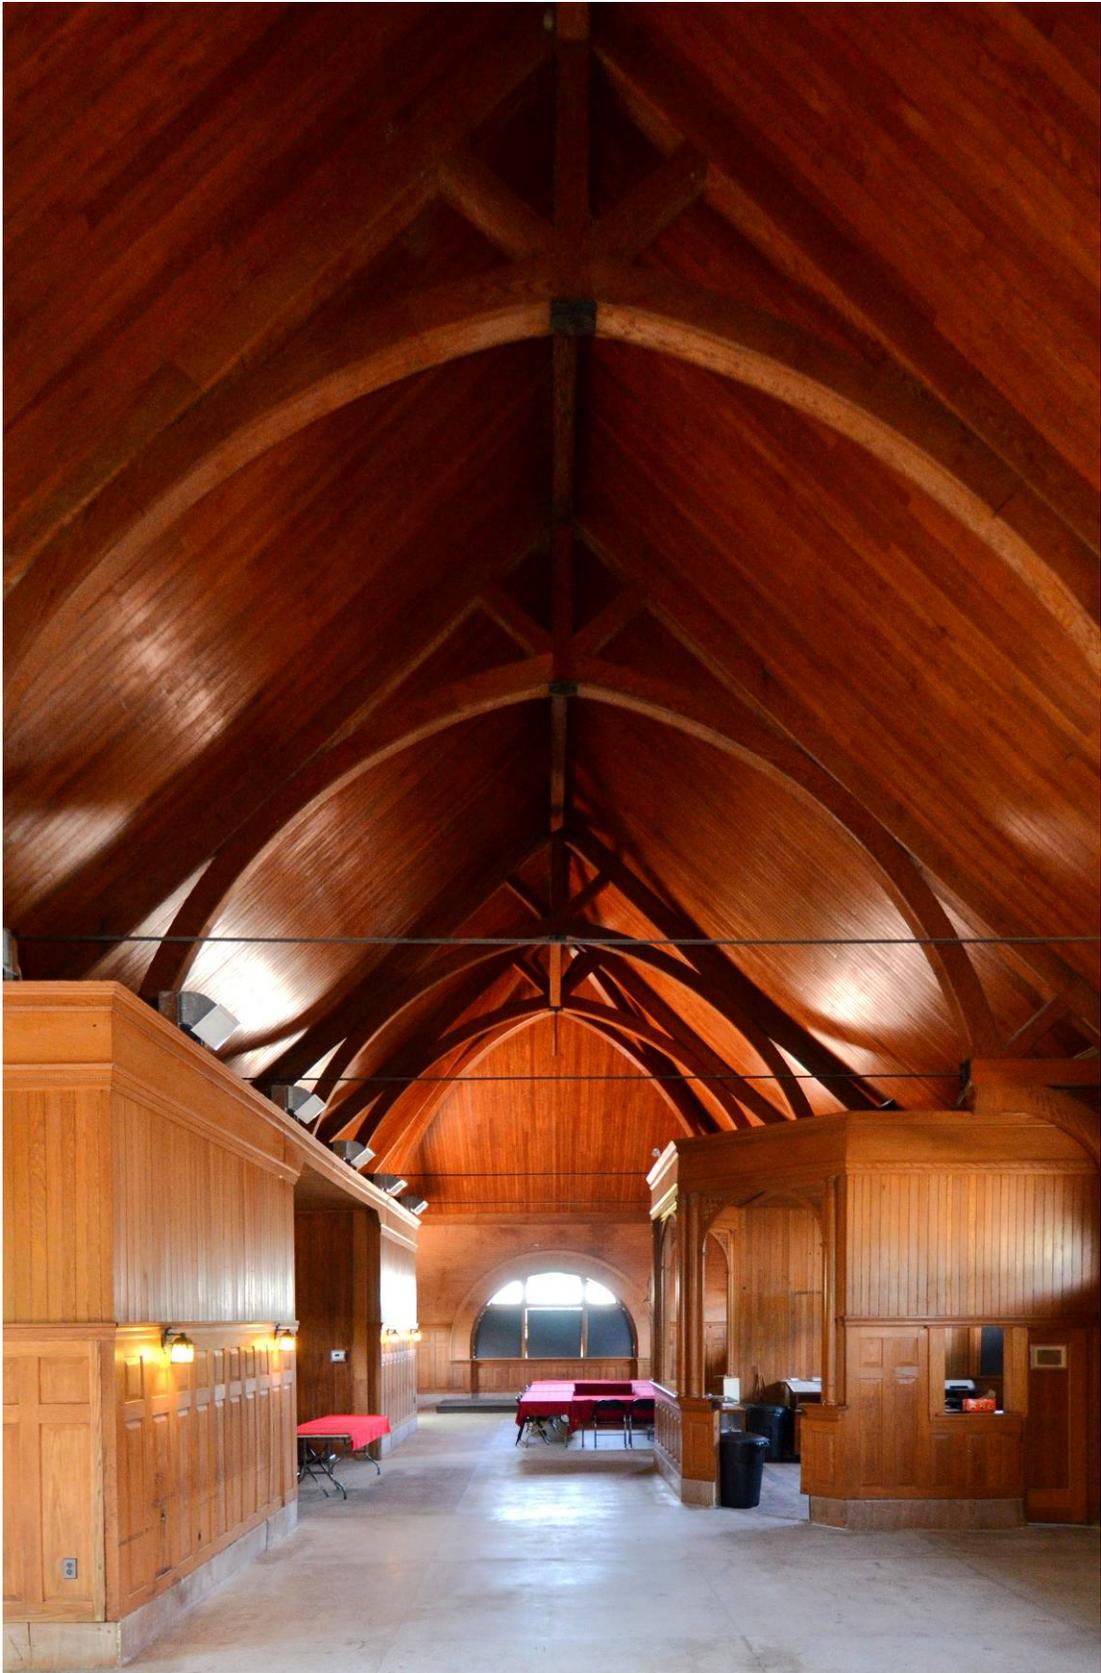
**Fig 51. A view of the waiting room looking upriver (May 2014).**

The waiting room was partially restored in 1991, but rising damp and subsequent leaks have damaged the interior masonry and woodwork on the perimeter walls, particularly in the southeast corner and upriver wall. Moreover, budgetary limits in 1991 limited the extent and quality of the work completed. The bar should be raised for future work. Considerable work is still required to restore the waiting room to its former glory including carpentry restoration, wood refinishing, marble/quarry tile floor restoration and lighting. Modern conveniences, such as improved central air conditioning, radiant heating, concealed supplemental lighting, and accessibility should be accounted for in planning any sequence of work in the waiting room.

Working from the top down, the bead-board ceiling and trusses are in good condition. The grooves of the bead-board should be fully stripped of paint and stained to match, but much of the ceiling and trusses merely need to be washed, de-glossed and varnished, including the crown molding. Areas above the ticket office and alcove that were not stripped in 1991 are generally out of sight and can be left as a historic trace that “tells the story” of previous alterations.

For the areas that have not had subsequent water damage, the brick walls generally just need light cleaning. However, the southwest corner of the waiting room was temporarily stabilized in 2012 and must be partially reconstructed by skilled restoration masons using matching lime mortar and clean matching face brick to harmonize with the waiting room walls.

No significant restoration work can occur until final plans are in place for the adaptive re-use of the waiting room—in particular, how the alcove/washroom and ticket office are deconstructed and restored respectively to meet the needs of a new public venue. The washrooms are completely inadequate; larger, accessible washrooms must be constructed downriver in the center freight rooms. This will open up the space considerably, even if the ceiling structure is suspended to hide mechanicals, provide historical reference and retain architectural interest **[Fig 61.]**. The ticket office can remain a focal point in the room and possibly accommodate a small elevated stage if the side walls are opened up more.

The millwork must be de-glossed, evened out, stained and varnished. The doors and windows must be stripped and refinished; this is the one room in the entire depot where the interior of the sashes originally had a faux bois (faux grained) finish to appear as oak and harmonize with the woodwork.

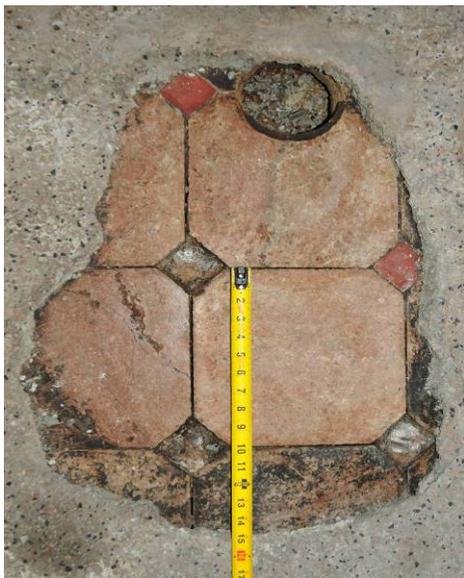
The original waiting room floor was elongated octagonal Tennessee pink honed-marble tiles accented with small red quarry tiles at the truncated corners [Fig 52.]. This floor was the most pronounced pattern found anywhere in the Keokuk Depot. A similar floor has been preserved in the Ozaukee County Courthouse (1901) in Port Washington, Wisconsin [Fig 53.]. Geometric stone and encaustic-tile floors were popular throughout the late 19<sup>th</sup> century in civic and institutional buildings as well as entry vestibules in private homes as championed by Charles Eastlake and other late 19<sup>th</sup>-century interior design trend-setters.

**Fig 52. Original waiting room floor.**

Restoring or reproducing the original marble flooring is an important aspect of restoring the original waiting room interior. This will be an expensive/disruptive endeavor that must be coordinated with the potential bathroom relocation and radiant-floor geothermal projects covered later in this section and under the MEP section. A mock-up effort to remove the terrazzo and restore the original marble must be weighed against the comfort, energy and lower maintenance performance advantages of a geothermal radiant floor. The original marble floor must be completely removed as well for radiant heating and salvage will likely prove cost-prohibitive beyond a small representative area for posterity. While there were many varieties of Tennessee marble in the late 19<sup>th</sup> century, most of the quarries are no longer in production. However, light and dark rose marbles are still available from a quarry in Friendsville, Tennessee that may prove to be a reasonable match to the original floor, if it cannot be salvaged. The red quarry tile insets are still readily available.

The most dramatic improvement will be the removal of the terrazzo flooring and either restoration of the original marble and quarry tile floor or its reproduction as required. Even if it can be salvaged and restored, this decision may hinge on the introduction of a geothermal radiant floor (see MEP).

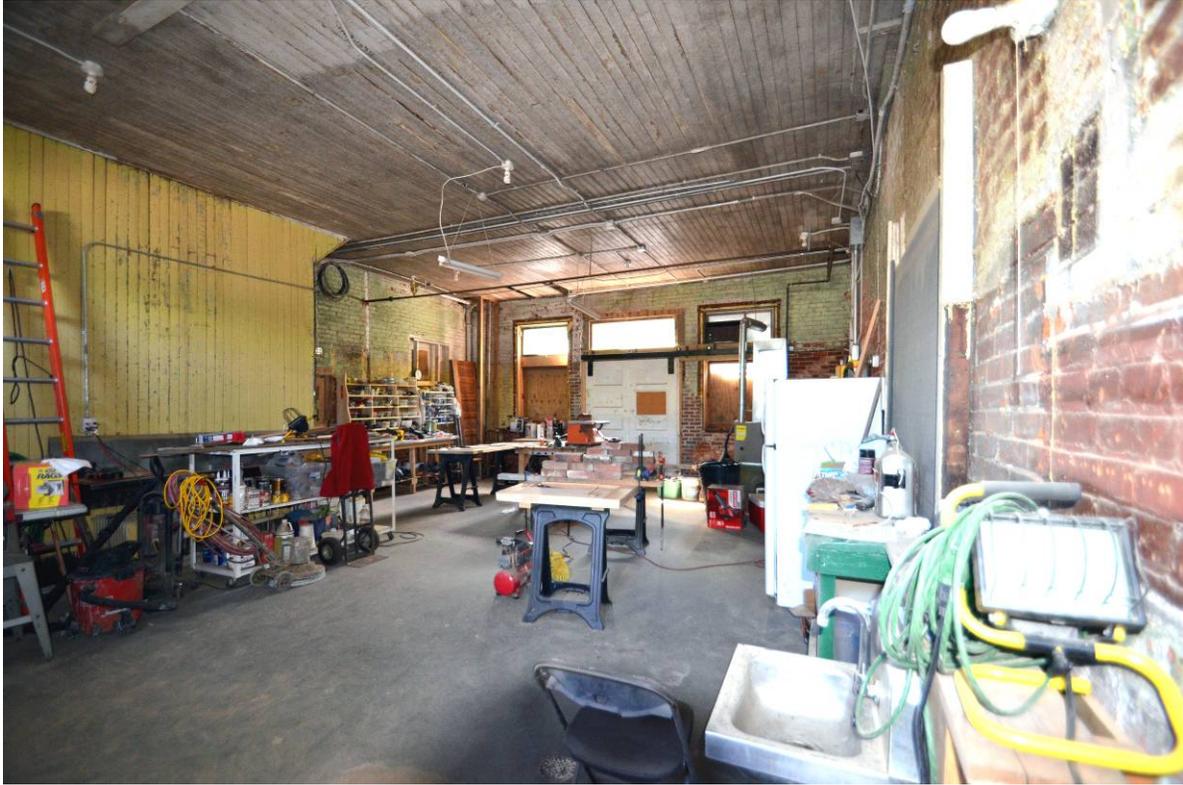
**Fig 62. View of baggage room toward Water Street (May 2014).**

Located on the first floor, under the central two-story core of the building, is the 33' x 24'-6" baggage room with an 11'-7" ceiling [Fig 62.]. This room has a temporary furnace and electrical panels in the north corner (see MEP). The floor is raw poured concrete, the walls are painted brick laid in a common bond, and the ceiling is  $\frac{3}{4}$ " x  $\frac{3}{4}$ " T&G lumber (probably originally sold as subflooring). The door and window assemblies have plain, flat (i.e. "square stock") casing and trim. With the exception of the floor, the entire room has been painted with multiple coats of yellow and white paint. Paint analyses revealed that these are all modern coatings, probably an effort to brighten the room after years of dirt and coal dust accumulation—and the result of higher light-level expectations compared to the Victorian's sensitivity to interior lighting. The brick was originally unfinished and all of the ceilings and woodwork in the baggage and freight rooms had a clear varnish—described as "hard oil" in the articles at the time of the grand opening. Fred Norman Vanderwalker, a prolific Chicago author on early 20<sup>th</sup> century finishes, described hard-oil to be a thin varnish as follows<sup>49</sup>:

Some areas of the brick walls have been re-pointed, but there is also some spalling and crumbling brick due to ongoing rising damp and freeze-thaw damage while the building is unheated or only intermittently heated. Small sections of the ceiling have been removed to incorporate temporary HVAC and electrical alterations to keep the station powered and partially heated as original or older systems were abandoned. Single bulb light sockets and hanging fluorescent fixtures have been installed on the ceiling which is today covered with exposed conduit and armored (“AC” or “BX”) cables since there is no attic above and fishing the electrical would have required partial removal of the ceiling or flooring above. Historic photos show that the room once had a 10” baseboard, but this was removed to install a drywall wainscot.

Among the highest adaptive reuse priorities is converting the 800 square foot baggage room into a catering kitchen. It will be **crucial to design the new kitchen in conjunction with planning the access to new washrooms** which must be located in the freight rooms downriver. The single existing doorway in the waiting room wall must be widened to allow for wheelchair passage and increased in height for walk-through passage (the header is currently 6’). A new oak bead-board partition wall, finished with historic cues drawn from the Depot, should separate the new hallway from the kitchen.

The wooden ceiling could be stripped and restored to a natural finish to add for historical reference and the charm in the kitchen. However, a dropped ceiling may be more desirable to absorb sound and provide a chase for electrical, plumbing and mechanical systems for the new kitchen and second floor above. The walls should ideally be furred out and insulated to improve comfort, reduce and isolate kitchen noise from the waiting room, and provide chases for all the electrical that must be added to support a new working kitchen.

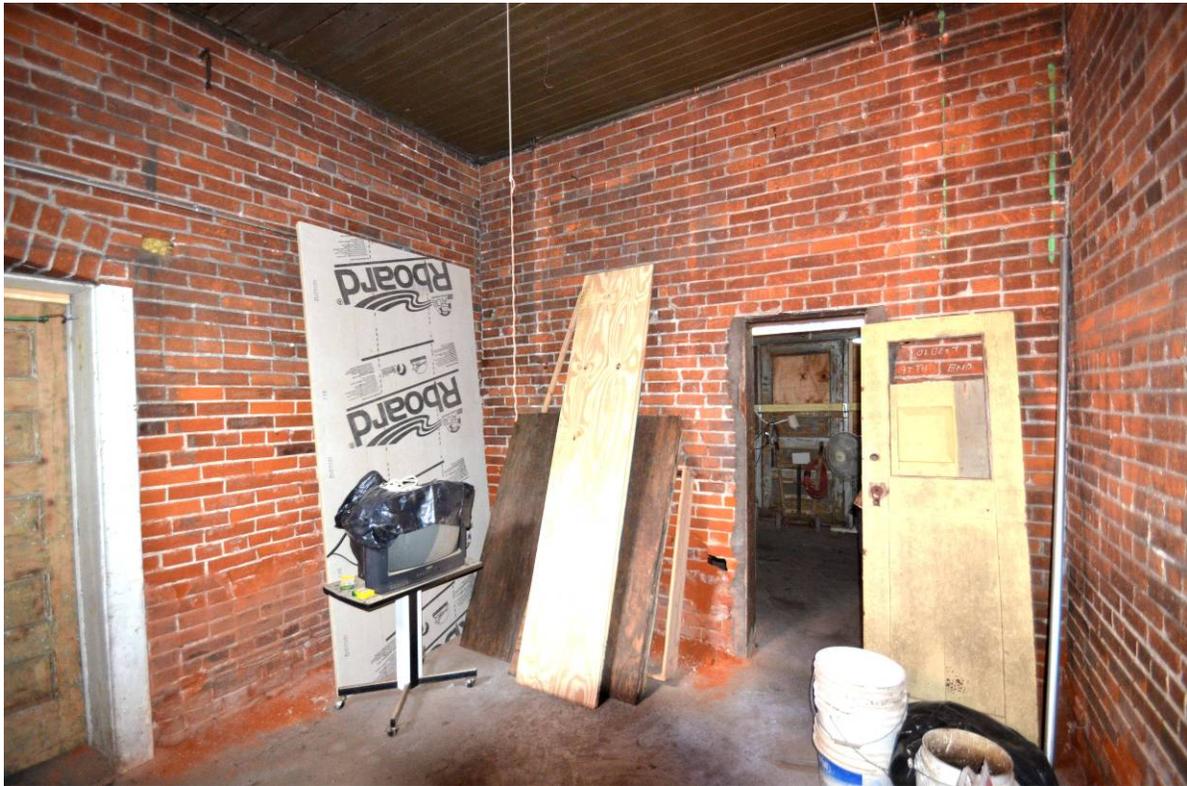
The conductor's equipment room (also called the "train men room" on early plans) is a small 11' x 10' space with a concrete floor, 10" wood baseboards, common brick walls laid up in common bond, and a 12'-6" ceiling of painted T&G lumber with a solitary porcelain-base lamp socket. There is no evidence of original shelving or wall brackets to hold equipment in this room and the brick walls were left unpainted. Free-standing metal lockers or cabinets may have been used originally. A double-hung window and a five-panel door with an operable transom that leads to Water Street are found on the west wall. The door, window casing and trim are all plain stock and pieces of the original door hardware remain. A narrow new door opening was added through the shared brick wall of the mail room. Rising damp has caused serious spalling in the lower brick courses [**Fig 63.**].

**Fig 63. Conductor's equipment room (May 2014).**

There are no current adaptive reuse plans to either utilize the original conductor's equipment room or display this space for historical interpretation. This tiny space may eventually be best utilized for storage (or cold-storage) or as an alternative mechanical room for the baggage room if it is remodeled for use as a kitchen to support programming in the waiting room. The lower brick walls require extensive repairs here prior to installing shelving or furring out these walls for drywall. The ceiling can simply be prepped and painted and the floor cleaned and sealed. If this room is converted for cold-storage, the window should remain with tinted black-out glass and the exterior door opening fixed as a false door and walled over inside (rather than bricking up these openings).

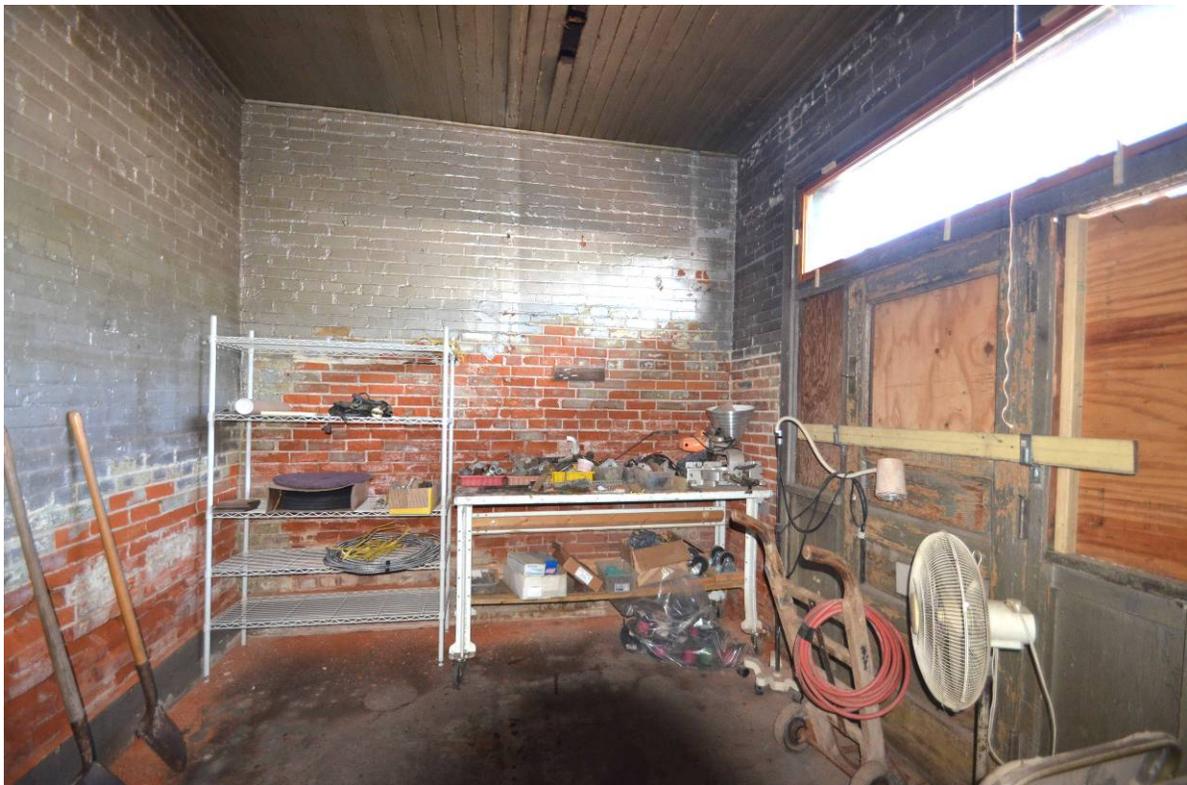
**Fig 64. U.S. mail room (May 2014).**

Trackside from the conductor's equipment room is the U.S. mail room [Fig 64.]. This small 11' x 10'-6" space has a raw concrete floor, 12'-6" ceilings and was originally accessible from the train platform only for the exclusive use of the U.S. Post Office. With the same materials as the Conductor's equipment room, the three-paneled door appears original with a single light and narrow sidelights with simple bulkhead panels below. A wide operable overhead transom spans the entire opening. The door glass or transom was presumably leafed "U.S. MAIL" or something similar to identify this room along the platform. A new rough opening was cut into the downriver wall leading into the freight rooms.

The walls, ceiling and woodwork were last painted silver like the adjacent freight rooms, indicating this space was still in use. However, rising damp and other freeze-thaw damage caused the "fire skins" on the lower brick courses to spall and crumble, exposing the porous red body of the bricks. If there were any original sorting bins, tables, service desk or shelving in this room, they were apparently freestanding here as well since there are no obvious anchors on the walls.

There are no current adaptive reuse plans to either utilize the original mail room or display this space for historical interpretation. This tiny room will likely need to serve as a transition space in the foreseeable future to allow traffic circulation from the waiting room and baggage room into the former American-Pacific freight rooms; particularly if the final design solution to increase the use of the waiting room includes the removal of the inadequate washrooms. Here too, the lower brick walls require extensive repairs.

This space may become part of a historic hallway or corridor where people moving from the waiting room to new washrooms would pass the restored trackside wall of the baggage room, restored stair hall to the second floor, and restored mail room. If so, the walls should be stripped and repaired by skilled masons and the ceiling should be stripped and restored with a natural finish/varnish. Period signage and lighting could be installed as desired. Alternatively, this small space could be inexpensively cleaned-up and remodeled with drywall. A temporary Space Pak HVAC installed in the attic might be installed to provide heating and cooling until the mechanical systems for the whole building are restored (ideally geothermal). The windows and doors must be retrofitted with thresholds, sweeps and weather stripping (see **Windows and Doors**).

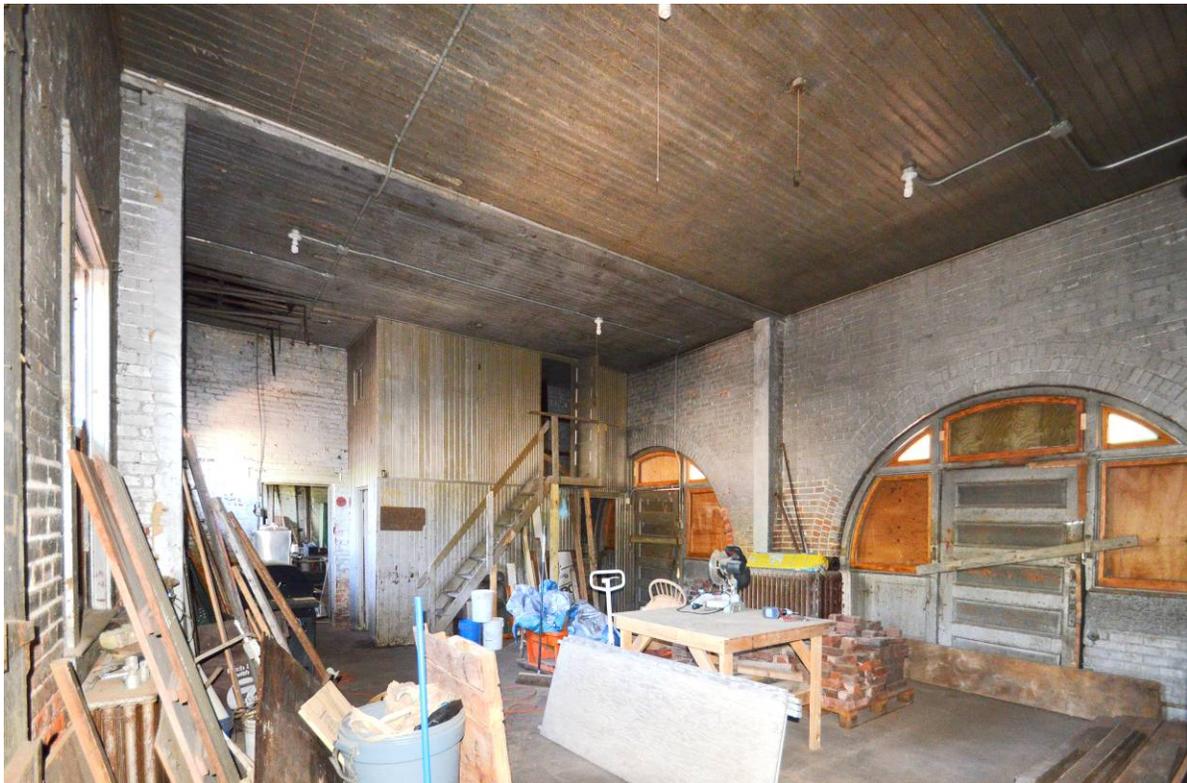
The U.S. & Pacific and the American Express freight rooms were combined into one 32'-6" x 21'-9" space, presumably after their 1914 merger [Fig 65.]. A crude doorway was added between this room and the Adams Express room. The floors are concrete, the walls are common brick laid in common bond, and the 12'-6" ceiling is wood ¾" x 3¼" T&G. The walls and ceiling have been painted several times and the deterioration of the common brick in the lower wall is similar to the conditions found in the baggage room, conductor's equipment room and mail room. The ceiling and walls of the combined American and U.S. Express freight rooms were last coated with a silver paint that contains lead. The Adams Express room is painted mint-green color that does not contain lead [Fig 66].

**Fig 65. Brick plasters locate the original wall that divided the freight rooms (May 2014).** Each freight room had entrances on both the bluff side and trackside for the efficient and smooth circulation of goods from the train platform to Water Street; the door openings are centered on

There are no immediate adaptive reuse plans to utilize the combined original American-Pacific Express freight rooms or display this space for historical interpretation. It is currently being utilized for material storage to support volunteers in their efforts to repair and clean up the Depot. In the long term vision for the Depot, this space will best serve as new men's and women's accessible washrooms to support the increased use of the waiting room. In the interim, this space could be rehabilitated for use by a small start-up or boutique business to generate income once electrical and HVAC is installed, but will require considerable work prior to occupancy.

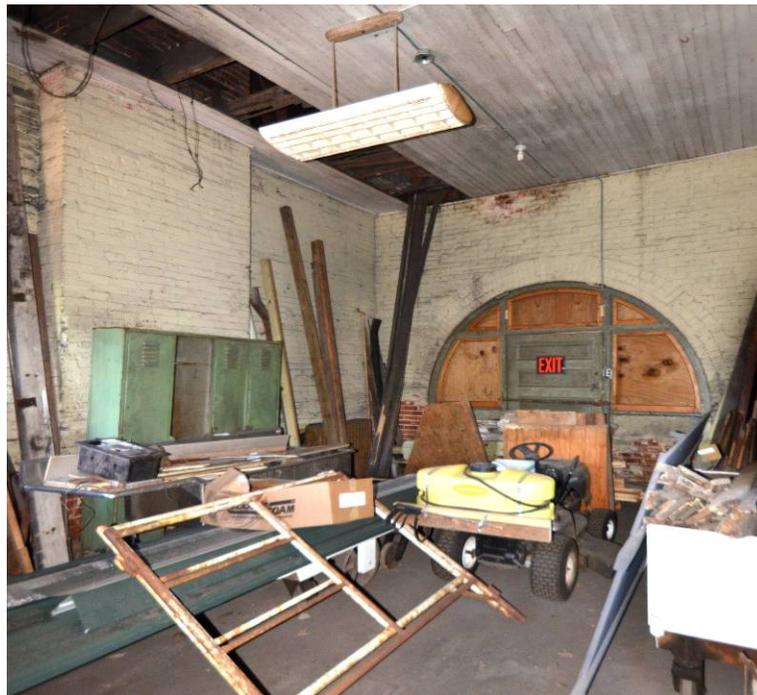
**Fig. 66. Adams Express freight room (May 2014).**

The T&G ceiling is collapsing from roof leaks which must be deconstructed, stripped, refinished and reinstalled prior to the safe usage of the space. The green paint on the walls does not contain lead and would be less expensive to strip. However, the price to chemically strip the walls (see MASONRY) will be considerably more than the cost to simply fur them out to install insulation and drywall. Another option to maintain the industrial feel of the space is to strip the interior walls and simply fur out the two smaller exterior end walls. The concrete floor can be cleaned and sealed or finished as desired for the intended adaptive reuse.

The ceiling should be stripped and restored to a natural finish; the silver paint in this room contains lead and must be properly stripped and disposed. The same silver paint found on the brick walls here will increase the cost to chemically strip the walls, but stripping will retain the industrial feel of the room. It will be much less expensive to simply furr out the walls to install insulation and drywall. Another option to maintain some of the industrial feel but still improve the insulation in the space is to strip the interior parting walls and simply furr out the end walls. Furring out the walls, or installing a furred out wainscot around the perimeter of the room, will provide a place to conceal the new electrical if desired. A temporary Space Pak HVAC installed in the attic could provide heating and cooling until the mechanical systems are restored to the whole building. The concrete floor can simply be cleaned or finished with epoxy as desired for the intended adaptive reuse. The windows and doors must be retrofitted with thresholds, sweeps and weather stripping.

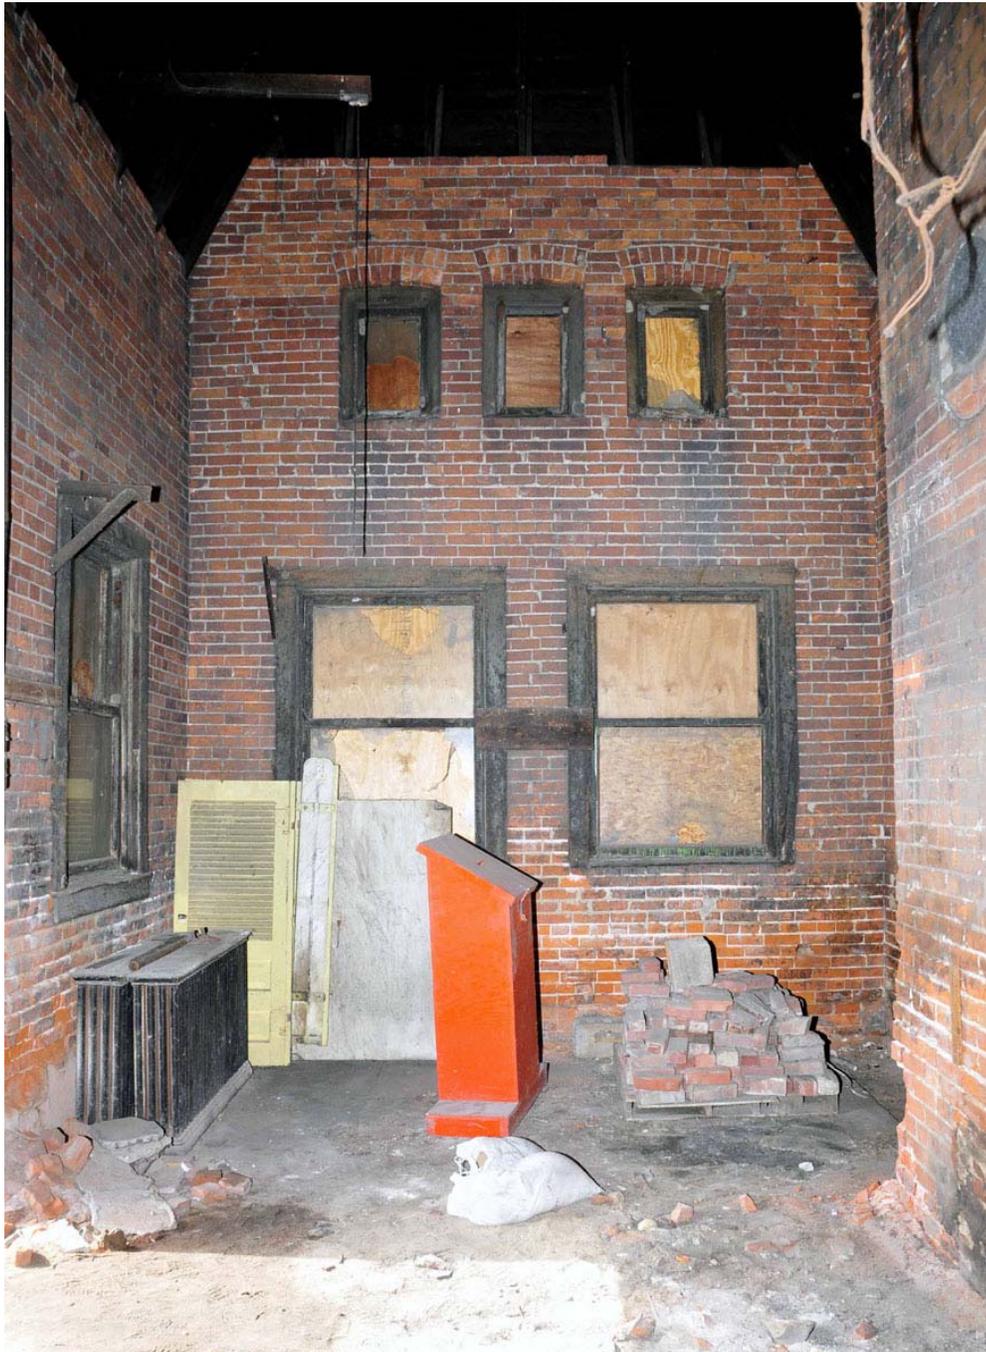
The boiler room is isolated on the downriver end of the building. This 14' x 24' space has a dirt floor and common brick walls laid in common bond. It was never painted so the walls and wood finishes here provide the best documentation and feel of the original freight rooms [Fig 67.]. The gable-end walls are 17'-9" and the roof peak reaches 30' to echo the waiting room roof height on the opposite end of the Depot. The boiler chimney stack is centered on the upriver wall separating the boiler room and the Adams Express freight room. Historic articles noted that there were "two large upright boilers" to generate the building's steam heat (see MEP section).<sup>54</sup>

**Fig 67. Bluffside wall of the Boiler Room (2013).**

There are no immediate adaptive reuse plans to utilize the original boiler room or display this space for historical interpretation. The historic integrity of the boiler room remains very high and the lower brick walls should simply be repaired and cleaned per recommendations in the MASONRY section. Although this room could also serve as a "boutique" office space, it will not have interior access to washrooms and given the original access to the steam tunnel (and relative ease of isolating this space with fireproofing materials) it will best serve as the mechanical and electrical room for the rehabilitated Depot.

A 4" concrete floor should be poured and a fire-rated ceiling should be installed just above the main floor windows (approximately 12') and just under the upper windows to isolate this space from the rest of the building. To facilitate future attic/roof inspections and repairs, a steel access ladder should be mounted on the upriver wall with a fireproof ceiling hatch. This will provide access to the entire attic over the freight rooms, conductor's equipment room, and mail room. A new steel trap door should also be installed to access the steam tunnels. (Work required in the steam tunnels is covered under the MEP section). The doors and windows should be restored as identified on the Window & Door Schedule.

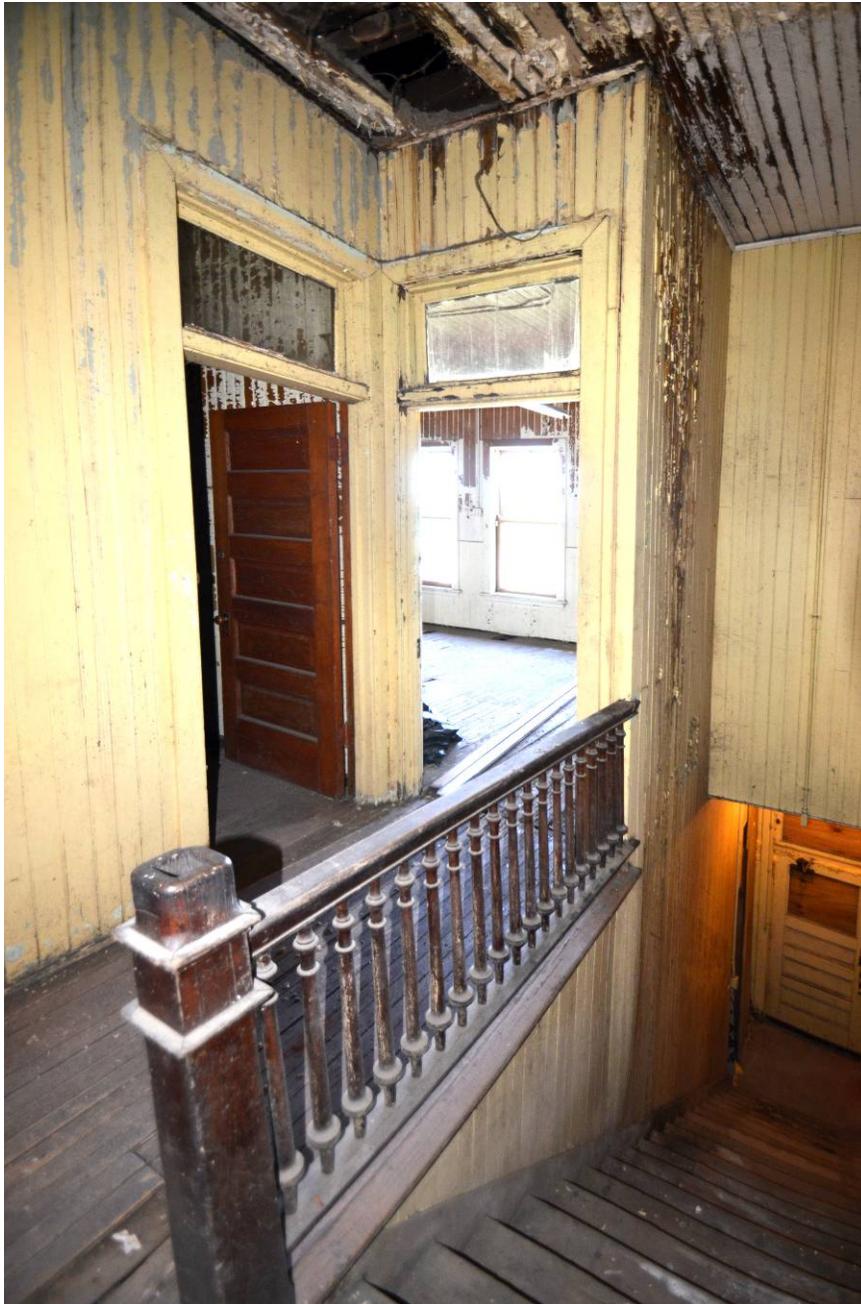
The stairs are listing to the upriver partition wall and must be reconstructed prior to utilizing the second floor. An original plain round handrail with decorative cast iron brackets is located on the downriver wall. The door and transom are beat up from heavy use and abuse. The glass is missing and boarded up and multiple locks have been installed on the door, evidence of many years of break-ins while the Depot was mothballed. Period transom hardware and a door closer remain, as well as the majority of the original lockset and rope-twist pull. A section of bead-board was removed in the vestibule to allow interior passage from the baggage room in 2013.

Fig 69. Stair hall and second floor railing (May 2014).

The stair hall must remain as the only access to the second floor. However, the stairs are deteriorated and listing. They must be reconstructed and this will provide an opportunity to shift the stair case slightly as required to allow for a new hallway from the waiting room to new accessible washrooms (assuming the baggage room is rehabilitated as a kitchen and catering/serving room). This will be a challenging alteration since the stairs are already steep and the space at the landing at the top of the stairs is already small. The stair pitch may need to increase slightly or ell at the top (or a combination of both) to allow for reasonable wheelchair clearance in the hallway. This would necessitate milling a reproduction section of railing to follow the ell. This may also necessitate closing off the bathroom door and cutting a new doorway from the bunkroom to allow for sufficient room at the bottom of the stairs (including reversing the door swing here to swing out).

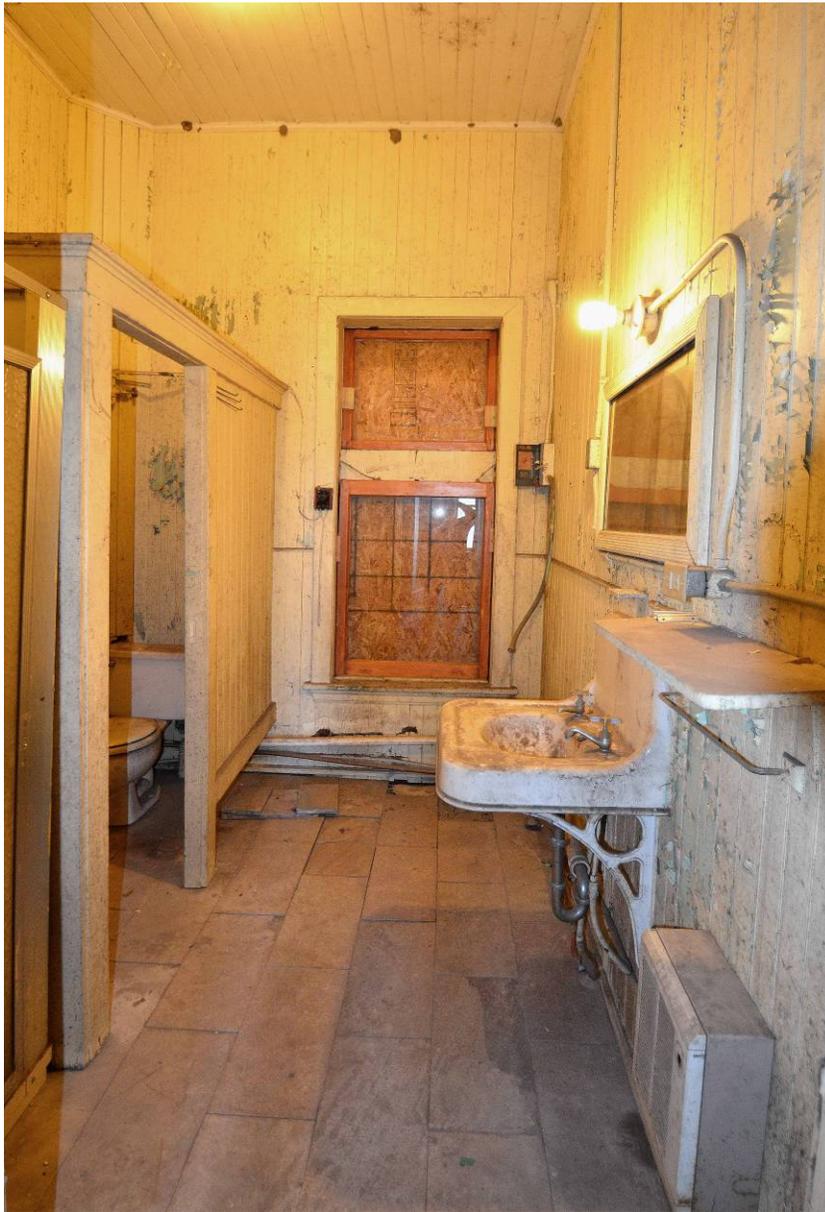
The employee washroom is a small simple space with tall proportions [Fig 73.]. The walls and ceiling are heavily painted bead-board, the floor is 10" x 20" Tennessee marble tiles. The wall-mounted porcelain enameled cast-iron sink is cantilevered on painted cast-iron brackets. The faucets appear to be from the 1930s. In the corner, a painted bead-board stall now screens a replaced toilet fixture. A fiberglass shower stall unit is located adjacent to the toilet stall, presumably in the same location as the original shower stall. Various wall mounted shelves have been installed by the sink, as well as a beveled mirror with a reeded frame. Exposed conduit runs to power outlets and simple exposed bulb base plates that have been installed over the sink and on the ceiling. An electric wall heater was added in here as well. Historic newspaper articles note that this bathroom was once fitted similarly to those in the waiting room.

Fig 73. Employee washroom (May 2014).

The employee washroom is currently unused and there are no immediate adaptive reuse plans to refurbish this room or utilize it for historical interpretation. This room is considerably altered with only a few items worthy of salvaging including the original sink, beveled mirror, and the Tennessee marble flooring. The floor tiles might be harvested here to complete Dutchman repairs to the marble flooring in the ticket office. This bathroom could eventually be refurbished in conjunction with the depot master's office and bunkroom. If the second floor is ultimately used for office space, the bathroom can remain a half-bath; if the historic overnight guest-stay experience is pursued, a small shower could be reintroduced here as well. Virtually all other surfaces, trim and fixtures in the room must be completely stripped and repaired or replaced.
