MASONRY

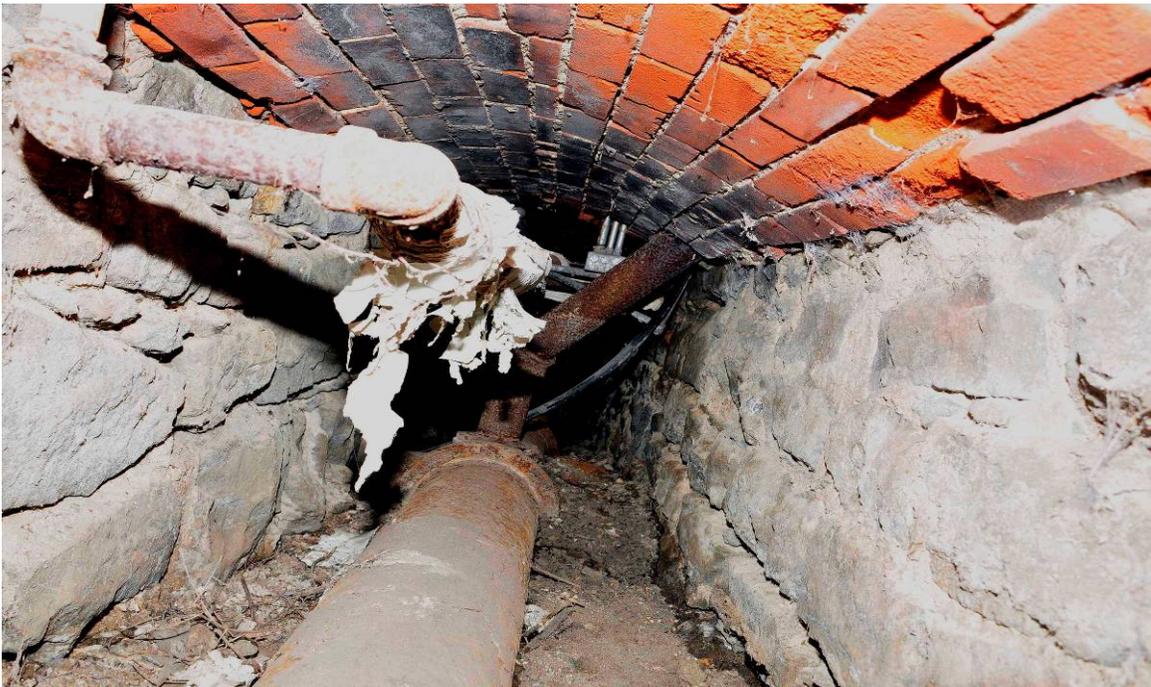
Access to perform a complete survey of the steam tunnels was limited due to numerous pipes and friable asbestos [Fig 29.]. Much of the Depot is reportedly built on bedrock but granite and limestone rubble footings and foundation walls are found throughout the steam tunnels. This material is generally undressed rubble laid-up with mortar in a random bond. The perimeter foundation walls are predominately granite, while limestone was employed for the interior tunnel wall. The builders used reliable granite to support the Depot walls, but were more frugal and resourceful where possible using marginal quality limestone where strength was less essential. Out of sight, the tunnel walls did not need to match. The source for the granite is unknown, but presumably came from one of the granite quarries in Iowa or the upper Midwest served by the rail lines that also served Keokuk. Keokuk had several limestone quarries and this material is presumably local if it was not simply excavated from the adjacent bluff. There is no evidence that the tunnels have ever been worked on since construction. Although the tunnels are generally sound for their purpose, a thorough survey and remedial repairs should be completed once the old piping and asbestos is removed. Given the moderate temperatures below grade, this work could be completed during late fall, early spring or even winter when masons are motivated to provide their most competitive pricing. Only limited material should be required to repair the walls; the brick vaults should be stabilized at the same time but should not require any significant reconstruction, which is fortunate given the tight confines.

Fig 29. Granite & Limestone rubble foundation walls in the steam tunnels.

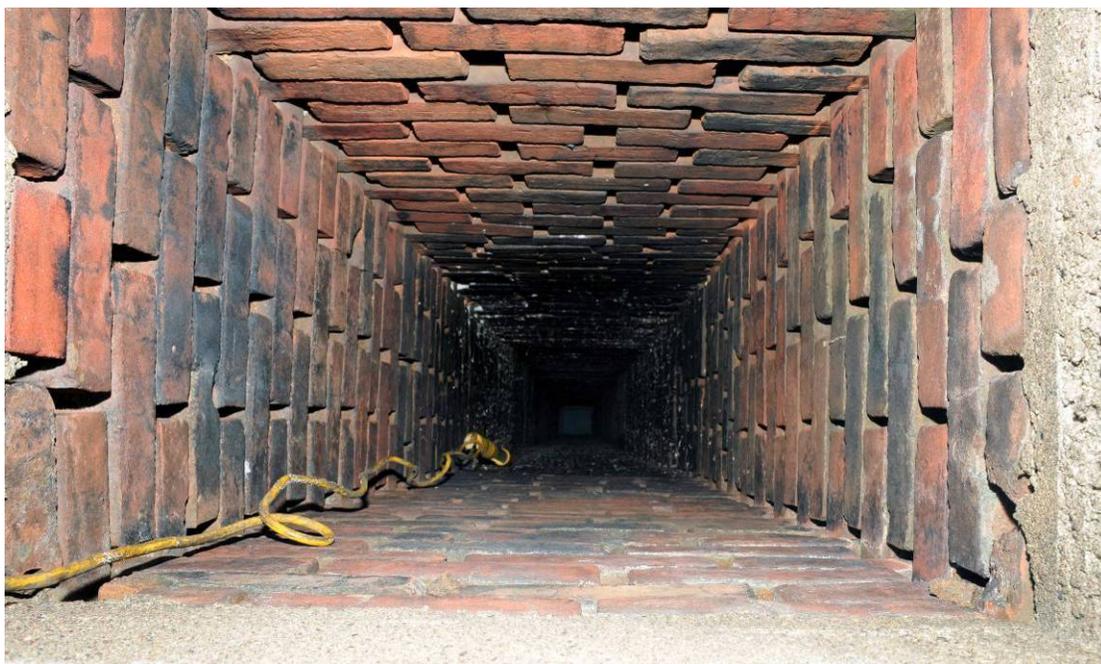
Fig 30. Common brick in the flue remains in good condition despite missing mortar.

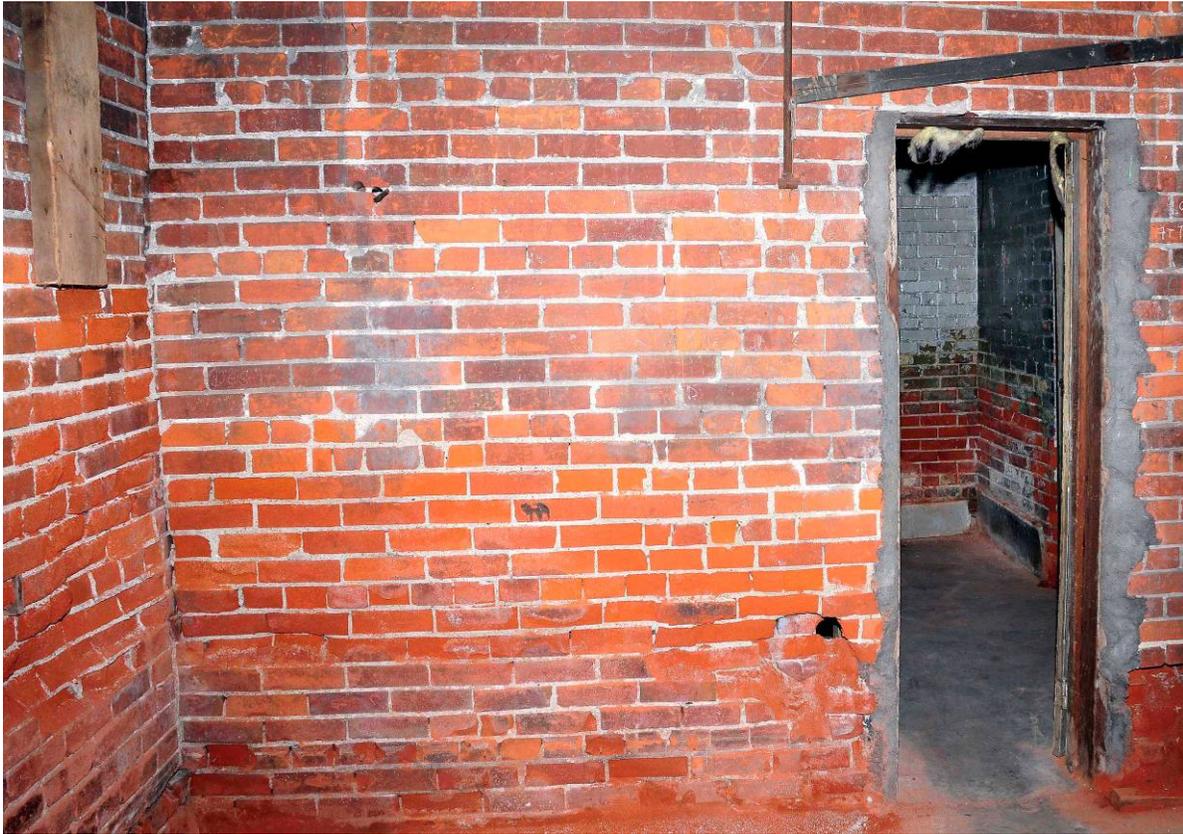
However, wherever the brick is saturated by rising damp, steam leaks (historically in the tunnel vaults) or roof leaks, and is not allowed to dry out, the fire skin is susceptible to spalling and the porous clay body is prone to accelerated deterioration. This is exacerbated when the bricks—which have a high porosity—are subject to wetting/drying and freeze-thaw cycles in intermittently heated or unheated rooms. These conditions are primarily attributed to rising damp since they are found in the lower third of the interior walls in all of the utilitarian rooms with common brick. However, poor roof and site drainage, and nonexistent flashing at the deteriorated mudsills are primary sources of the rising damp and are all contributing to the brick deterioration. The worse conditions are found at the base of the walls and are especially serious in the conductor's equipment room, mail room and boiler room leaving piles of brick dust on the floor [Figs 31., 32. & 33.].

Fig 31. Spalling brick in the lower walls of the conductor's equipment room.

There are currently no plans to restore any of these areas for historic interpretation. Repairing the walls with salvaged brick and lime mortar, to include a thru-wall flashing at the base of the wall, will significantly reduce rising damp and future deterioration. All load bearing walls must be repaired, even if they will ultimately be furred out and covered with plaster or drywall.

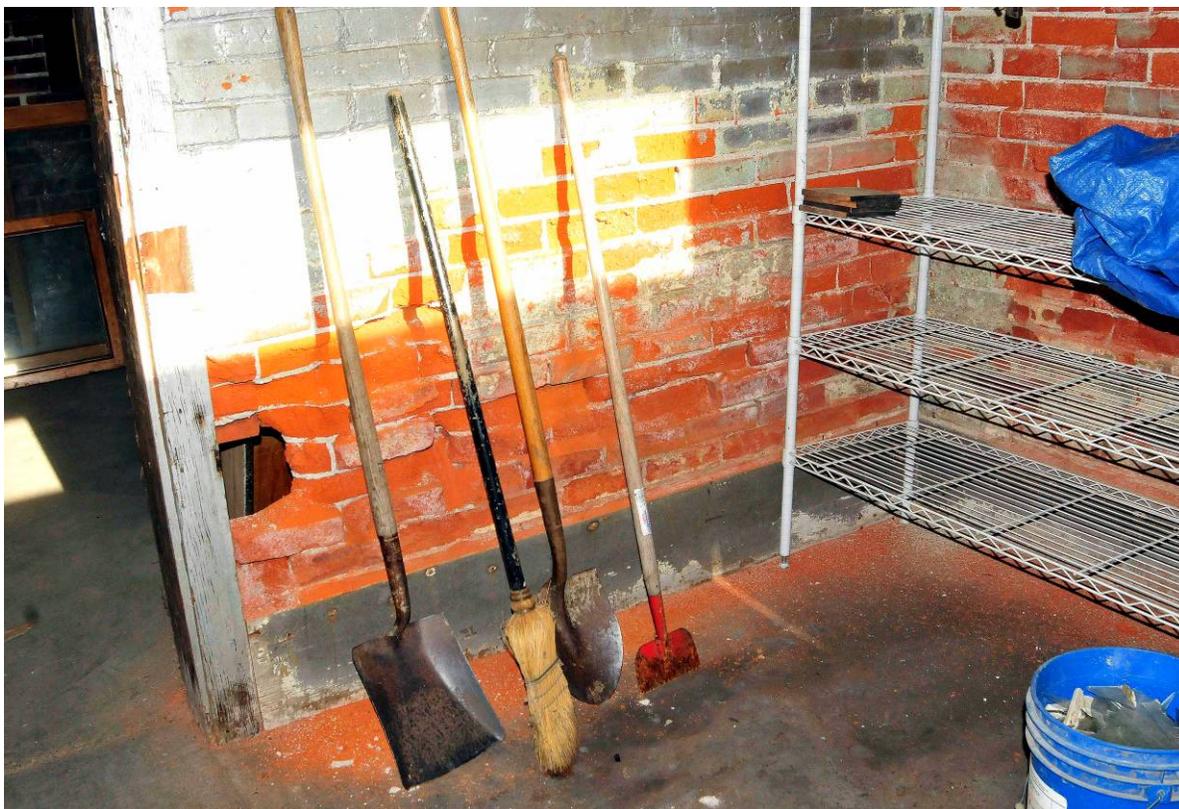
Fig 32. Spalling brick in the lower walls of the U.S. mail room.

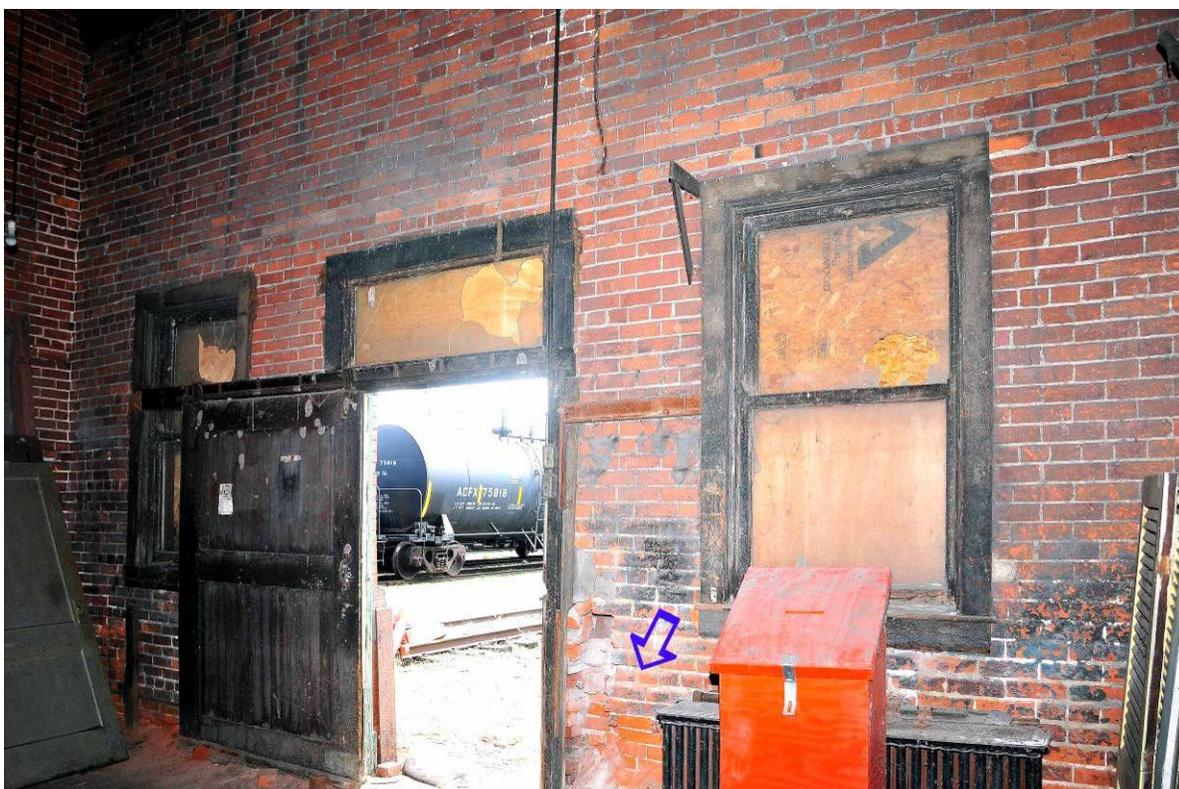
Fig 33. Spalling brick in the lower walls of the boiler room.

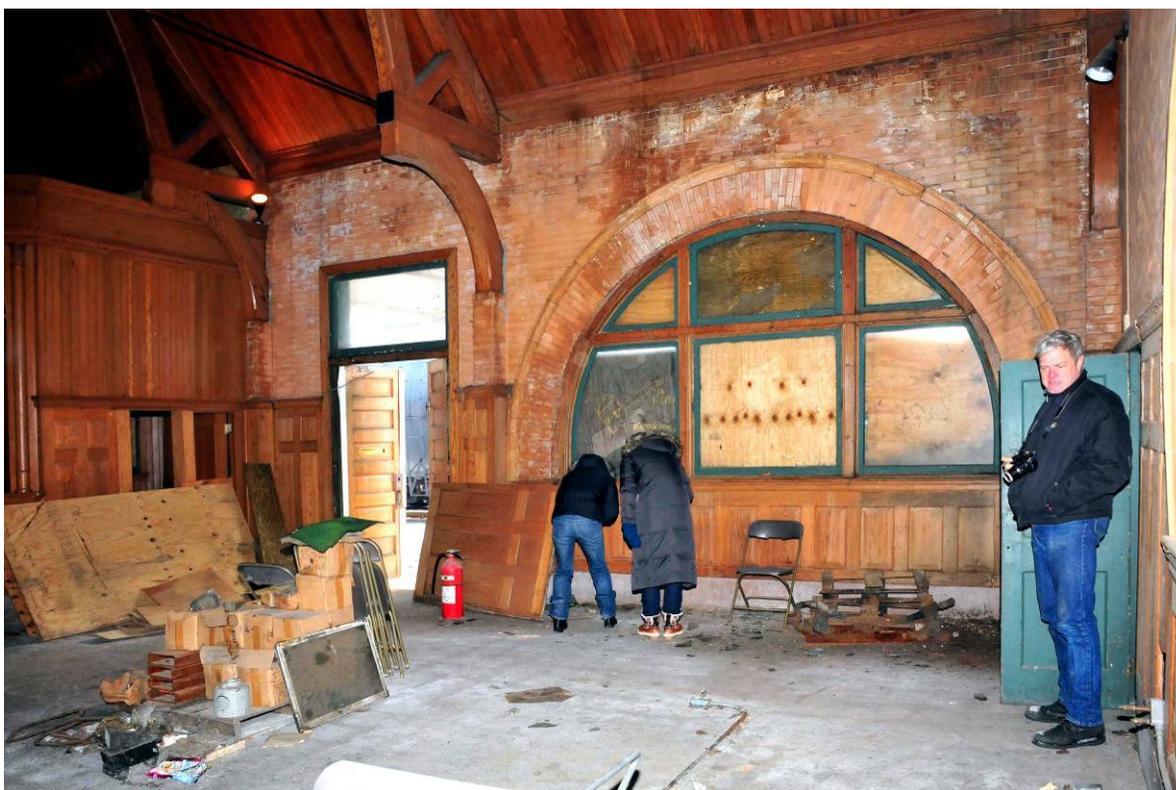
Fig 34. Stained brick in the southeast corner of the waiting room (January 2011).

Today, efflorescence and staining remains in the southeast corner of the waiting room. The wall has been stabilized but must be partially reconstructed and cleaned by professional restoration masons to restore the original appearance and eliminate the stains. If a matching brick is found, the source should be documented and additional stock purchased for proposed alterations to the waiting room in an effort to convert it as an event center. Brick may be required around the new doorways cut into the downriver baggage room wall to connect the future kitchen and washrooms, and potentially to the bluffside wall, if the final design solution includes removal of the alcove and washrooms from the waiting room.

If matching brick cannot be found, original brick can be harvested from above the ticket office and alcove/washroom to be used in more visible areas. This brick was not stripped during the work in 1991. The best available match can be then used to replace the brick in these concealed areas.

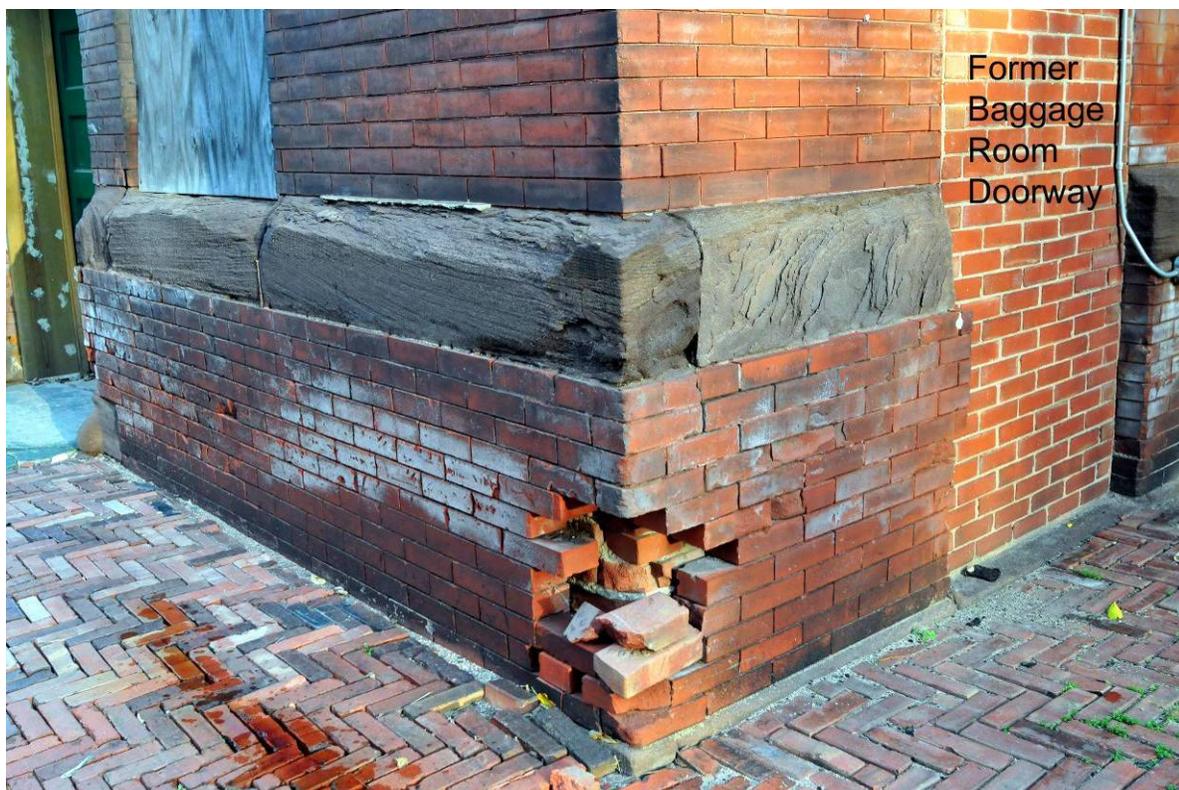
In the areas protected by the broad overhang of the eaves, the mortar joints remain in excellent condition and the brick only requires cleaning—including a few areas with graffiti. Despite excellent weathering properties and the good condition of the brick overall, approximately 20% to 30% of the brick must be repointed, typically immediately above or below the sandstone water table. While spot repairs are necessary above, the vast majority of work is concentrated below the water table around the entire perimeter of the building—particularly at the outside corners and doorway jambs to the baggage room, freight rooms and boiler room [Fig 36.]. Some corners were accidentally hit by freight carts or trucks, and a few damaged areas can be attributed to vandalism.

Fig 36. Typical brick repairs at outside corners on bluffside of building.

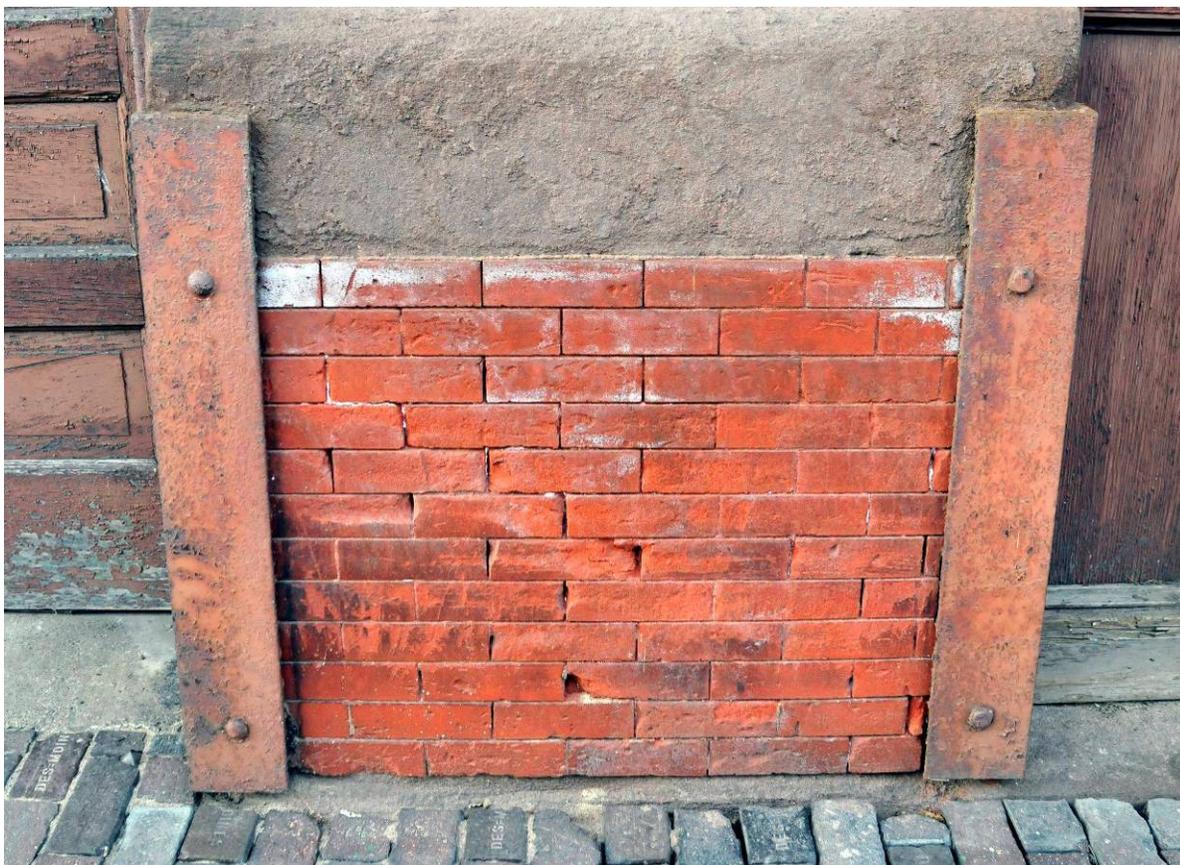
The brick doorway jambs likely sustained damage in the initial years of Depot operations. The 1907 panoramic image of the Depot shows the heavy steel angles found at the door jambs of the utilitarian rooms today were already installed to protect them from the impact [Fig 37.]. The extent of brick damage behind the steel angles is unknown, but it is presumed that the outer bricks along the edge will require replacement at the very least. Beyond physical impact, the masonry below the water table has sustained considerable rising damp and freeze-thaw damage covered previously under **Common Brick**. Here too, the worst damage is concentrated on the bluffside of the building although prevalent around the entire perimeter [Fig 38.].

Fig 37. Steel angles installed to protect low corners from impact of heavy baggage /freight carts.

Due to significant invasive masonry work required to the mudsill and water table around the entire building, the face brick below the water table is slated for complete reconstruction (see Sandstone). A skilled restoration mason will be able to salvage and re-use nearly all of the brick. Nevertheless, approximately 600 new bricks will be needed so finding a good match is paramount. Since freight carts are no longer used at the Depot, the angles should be removed and the masonry repaired here in concert with the water table repairs.

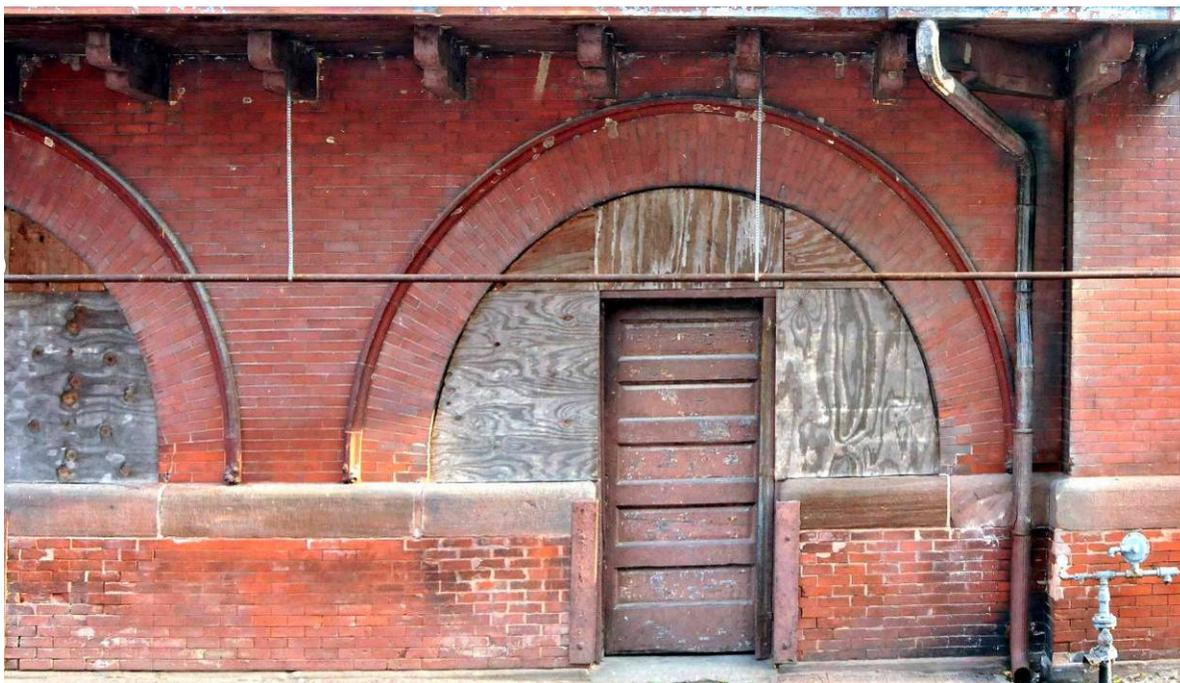
Fig 38. Most of the red face brick repairs are concentrated below the sandstone water table.

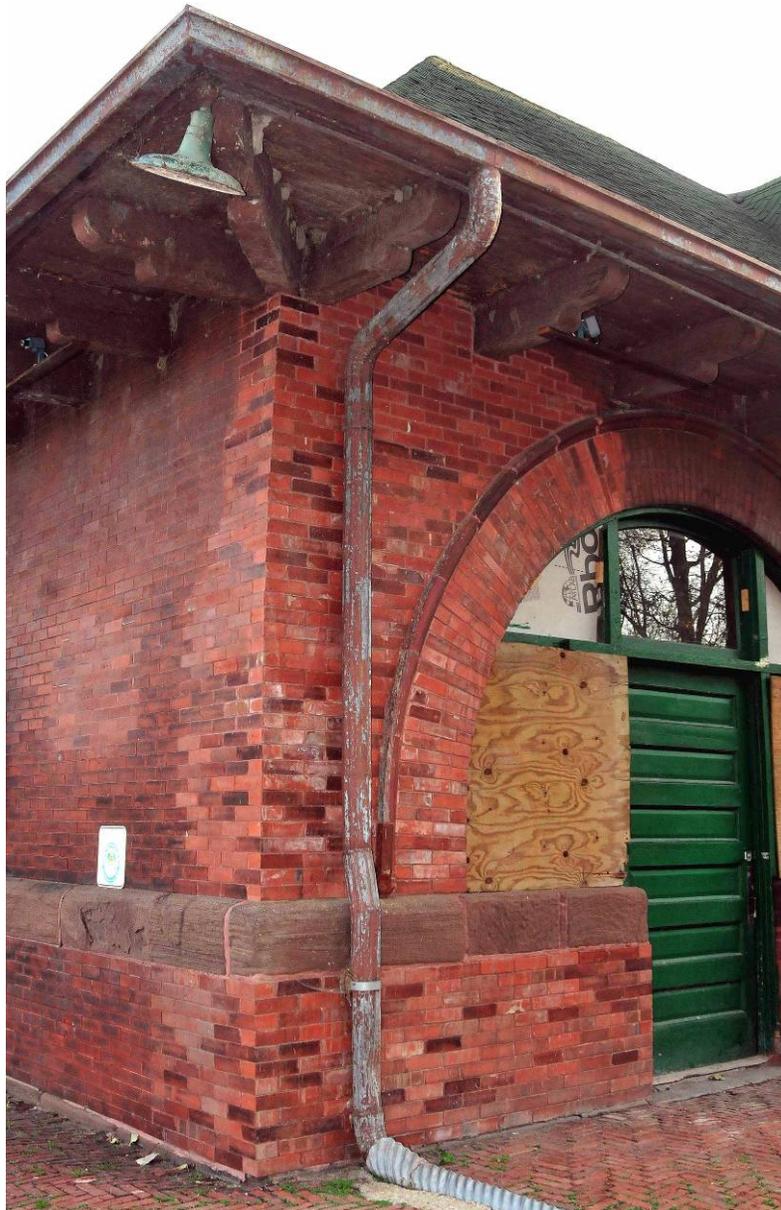
The northeast corner of the building was hit by a truck in 2001 and poorly repaired with mismatched brick. **[Fig 39]**. Although structurally sound, this patch should ideally be restored by skilled restoration masons with a better matching brick and appropriate lime mortar with tooled joints to match the adjacent original masonry. This corner must be carefully cleaned with the adjacent undisturbed brick to determine the final brick count for repairs; several hundred bricks may be required. In general this is a low priority compared to other masonry areas that are allowing water infiltration into the back-up masonry resulting in accelerated freeze-thaw damage in winter. Unfortunately, this cosmetic concern is located on a prominent corner closest to the main parking area that is next to the door used as the main entrance at this time. The cosmetics may be temporarily improved with Nawkaw masonry stains (or similar product) but these should only be applied to replacement bricks until a better match can be found. In general, such treatments are more successful when the replacement bricks must be stained darker to match the original.

Fig 39. Poor face brick repairs with mismatched brick and inappropriate mortar.

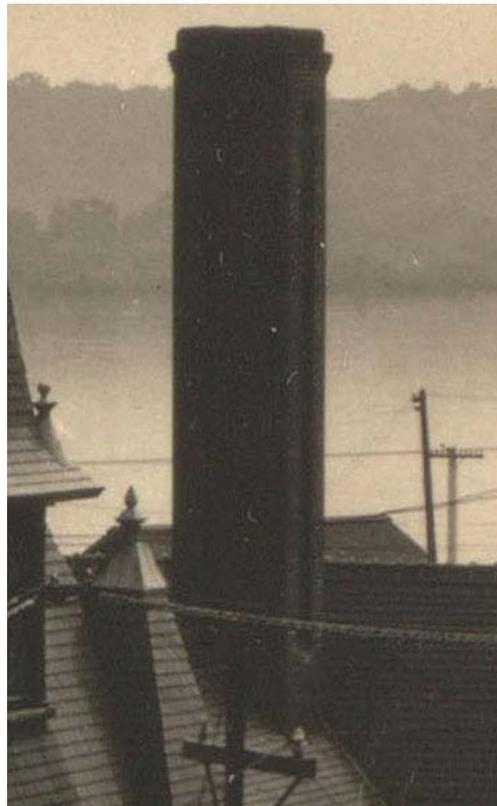
The chimney was lowered and must be reconstructed requiring approximately 260 matching red face brick (historic photos prove that the original stack was still standing in 1947 but was lowered by 1962) [Fig 40.]. Nevertheless, the stack is the tallest element on the building today and literally at the top of the list of items that must be restored in preparation of restoring the clay tile roof.

Fig 40. Original chimney stack.

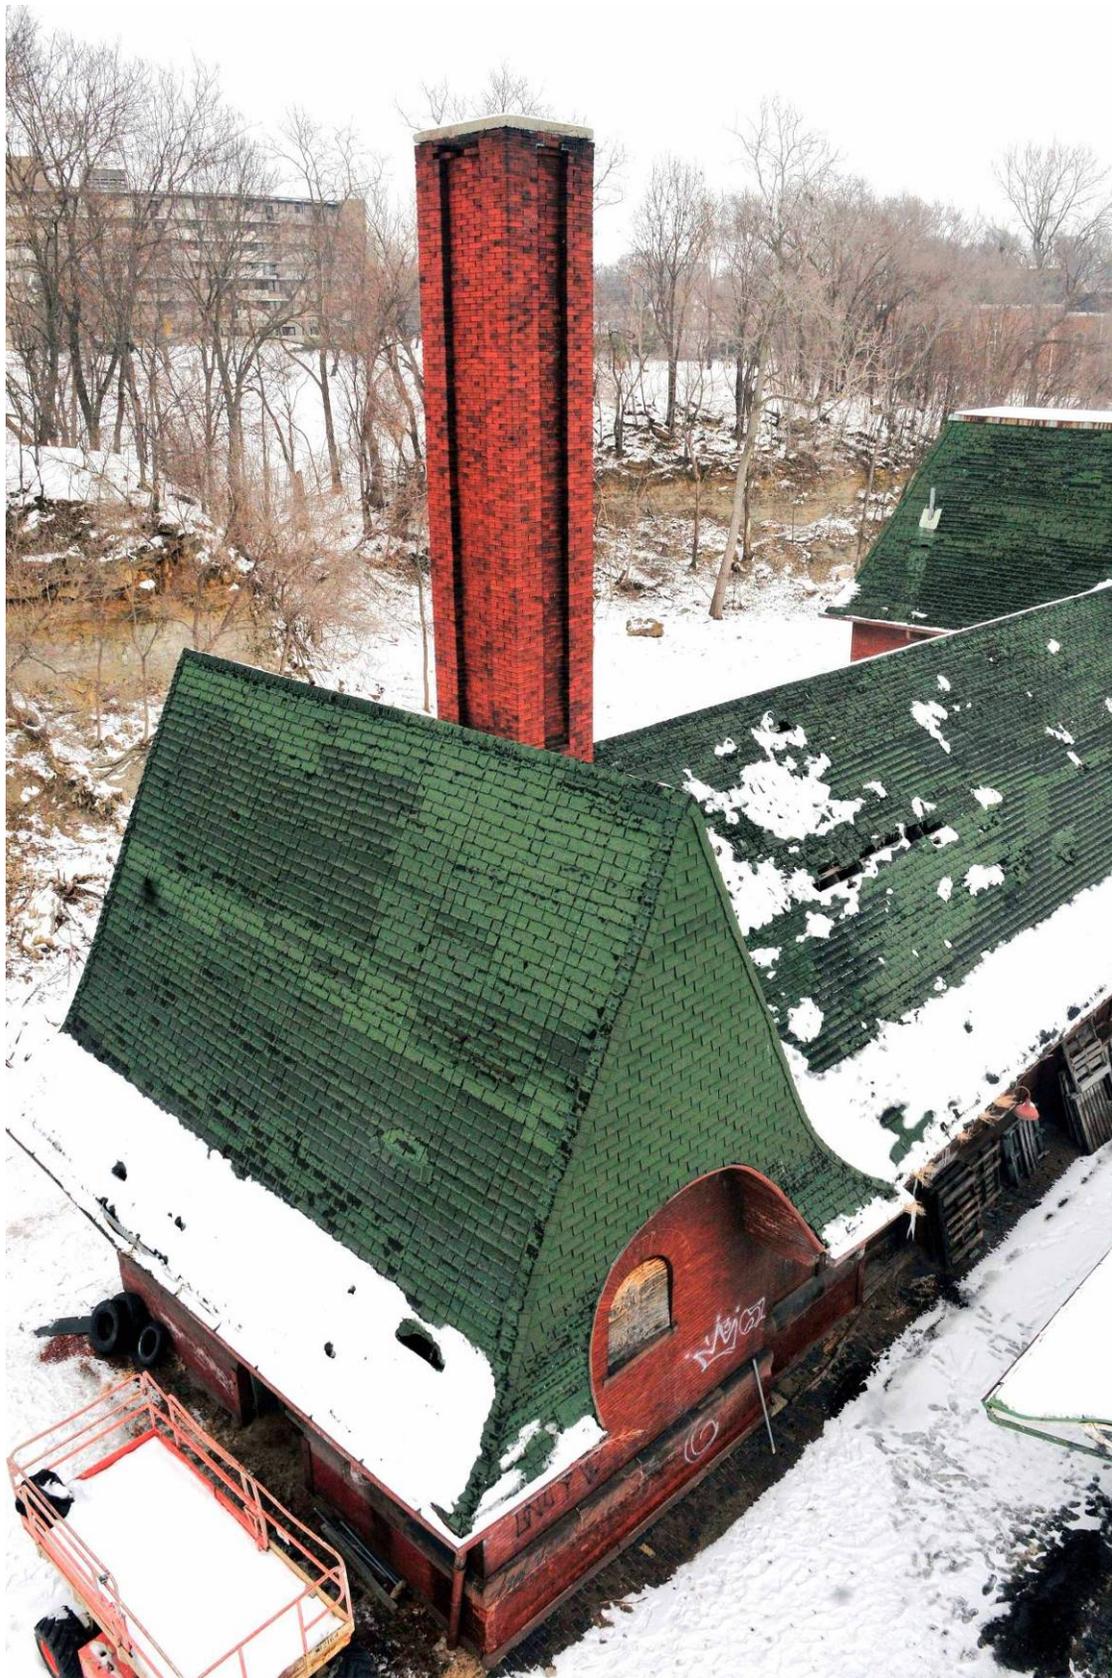
The chimney was inspected in 2011 with the assistance of the Keokuk Fire Department [Fig 41.]. It is deteriorated with missing mortar and loose bricks, and is currently capped with an aesthetically inappropriate concrete cap [Fig 42.]. The cap is not properly flashed and is causing the upper courses of brick to spread apart from freeze-thaw expansion; loose bricks are beginning to fall out of the top of the chimney. The inner wythe of brick lining the flue was laid with very large head joints and minimal bedding yet the stack in general remains near-plumb after 123 years. The exposed upper stack (above the roofline) is common brick faced with a pressed-brick veneer laid up with narrow 1/8" "butter" joints; it has buttressed corners that add mass, stability and architectural interest. The original mortar of the face brick must be analyzed to determine the appropriate composition and color. Below the roofline, the chimney is a two-tiered straight stack of common brick laid up in common bond with wider 3/8" to 1/2" lime mortar joints. The lower stack has only minor deterioration at the dirt floor grade of the boiler room floor and is in stable, sound condition.

Fig 41. The shortened and deteriorate chimney stack with a concrete cap (January 2011).

Restoration of the chimney is paramount prior to restoring the clay tile roof and will result in considerable savings by avoiding protection and possible damage working above the new clay tile. The stack should be restored as an architectural element but will not be functionally required for the proposed new high-efficiency HVAC systems (which may include a geothermal system). The flue should not be capped off, however, as this can introduce new masonry deterioration issues—particularly since the open flue has been open for a century and is not exhibiting any concerns beyond typical mortar loss.

The proper restoration of the chimney includes the partial deconstruction and rebuilding of the deteriorated and missing brick courses at the top of the chimney with matching brick. The original corbelled (or stepped) design of the chimney at the top of the chimney common to 19th-century buildings should be restored **[Fig 42.]**. The entire stack above the roofline must be cleaned and repointed and a new 20 oz. copper step flashing will be installed at the roof juncture.

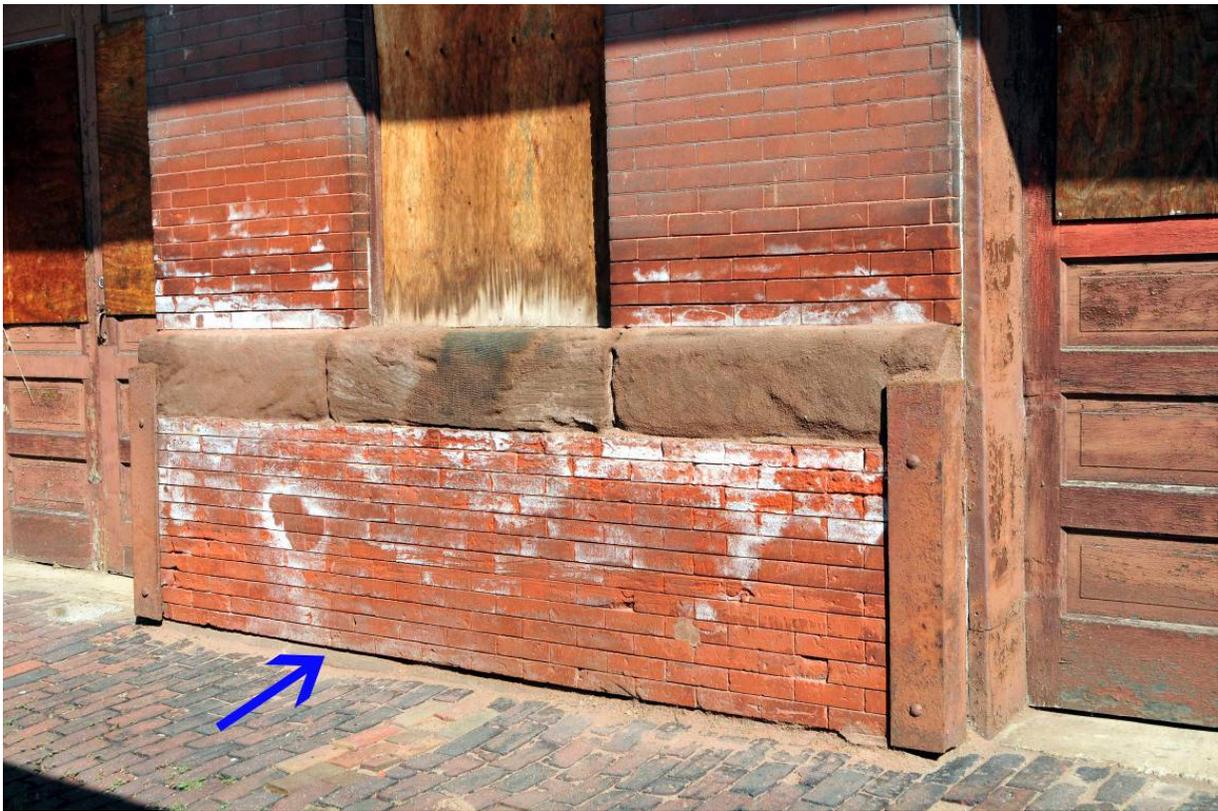
The deteriorated sandstone mudsills are causing a myriad of fundamental moisture related problems—namely rising damp—that call for even more drastic intervention [Fig 45.]. Given their discreet location at the very bottom of the wall, butting up to the brick hardscape, dark-red granite is recommended to replace all of the sandstone here. The aesthetic impact on the historic character of the Depot will be minimal and the granite, which has a much lower porosity, will perform far better in this location as a permanent repair and solution to the rising damp.

Fig 45. Porous sandstone mudsills are contributing to rising damp in the lower walls.

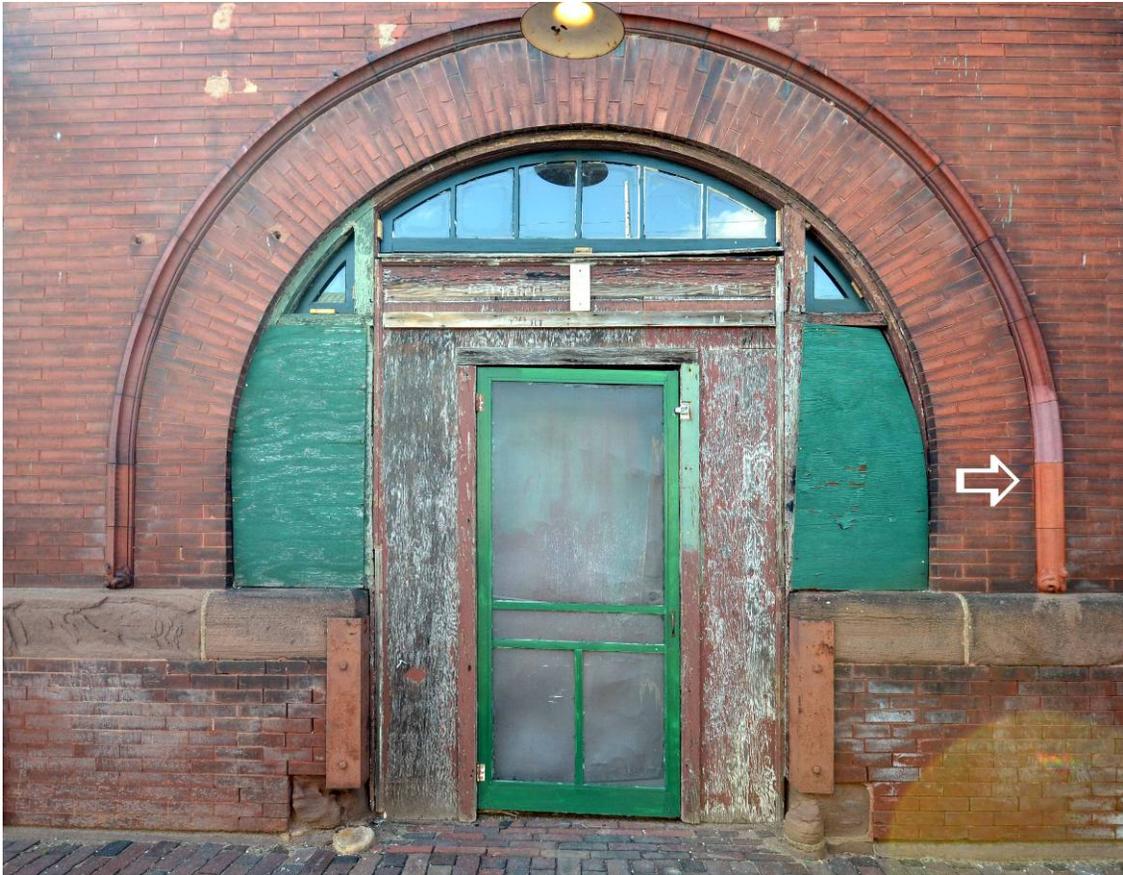
The exterior terra cotta lintels are found at all of the large arched windows and doorways around the Depot. They are thin-glazed reddish-brown in different profile from the interior lintels and terminate with a restrained foliage detail [Fig 46.]. These lintels also appear to closely match the hue and value of the adjacent brick; once both materials are properly cleaned a more pronounced, but intentional, color shift may be revealed to accent their presence. The vast majority of these pieces are in excellent condition requiring cleaning only. However, a few pieces have been damaged by overly aggressive cleaning or replaced with poor matches [Fig 47.]. These pieces should be replaced with a closer match when the masonry is restored.

Fig 47. Poorly matched repair of terra cotta window hood to baggage room.

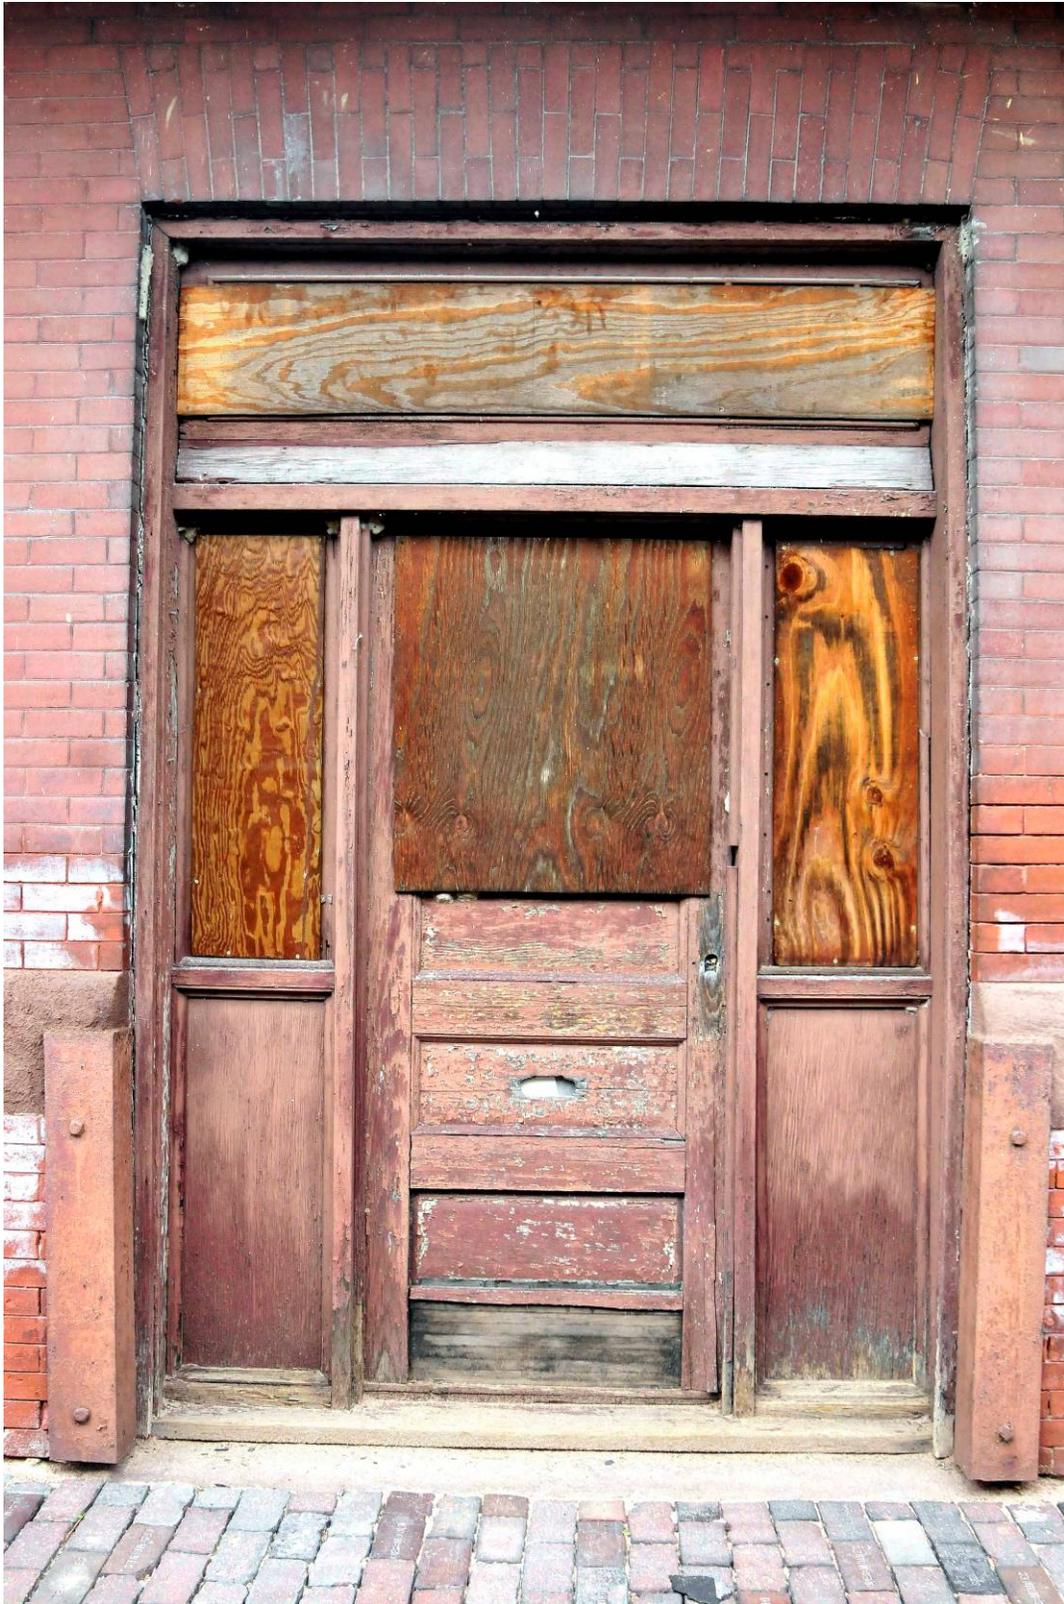
All of the window and door sizes and their configuration are detailed in the Window & Door Schedule in **Appendix D**. Virtually all of the original window and door frames and the vast majority of original window sashes and doors survived decades of neglect on the Depot. A few openings have been altered with replacement windows or doors as detailed on the schedule. The windows were all single-light, one-over-one double-hung, or single-lights surrounding a center-pivot window in the case of the arched waiting room windows. The large waiting room windows and doors are 2¼" stock, smaller window openings downriver tend to be 1¾" stock. The windows are all pine/fir while most of the doors are pine/fir cores with a thick oak veneer. Beneath decades of green paint, the original waiting room windows were faux grained to match the oak wainscot and trim on the interior **[Fig 48.]**. The door assembly on the trackside of the baggage room has been altered the most and requires complete reconstruction; approximately half of the openings are beyond practical repair and should be replaced with reproduction doors for a long lasting repair **[Fig 49.]**.

Fig 49. The mail room door assembly must be reconstructed to match the original design.
