**ROOF:**

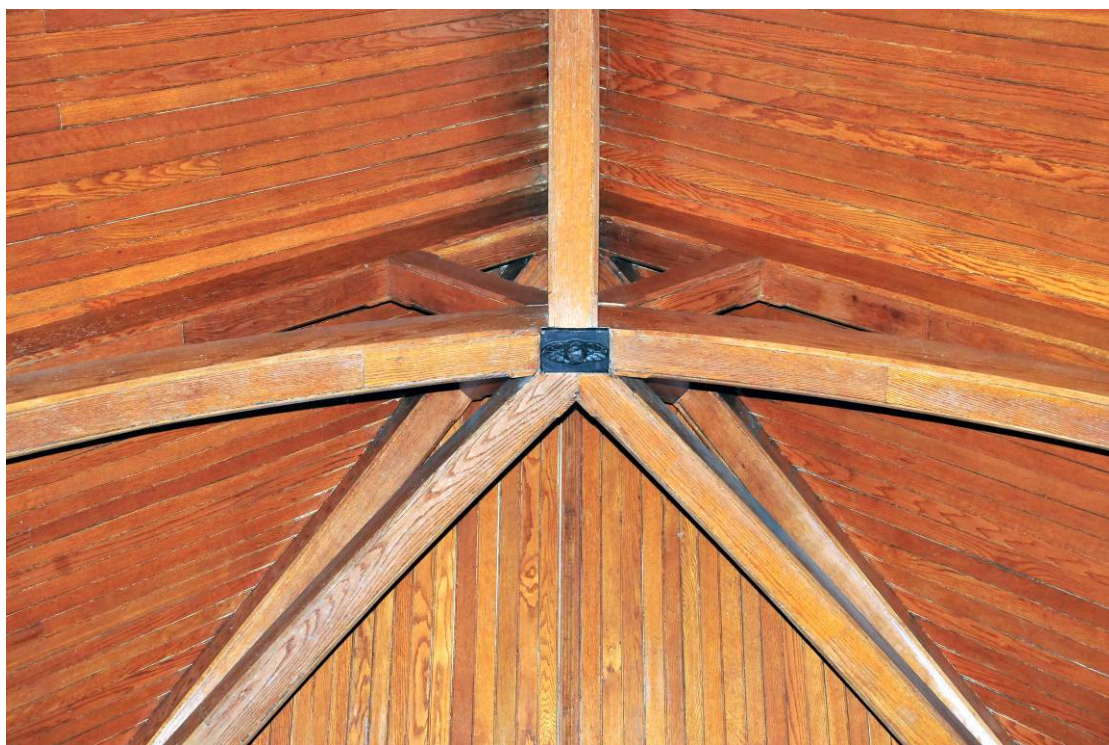
There are three separate roof systems: 1) the waiting room half-hip with a cathedral ceiling; 2) the full hip roof over the two-story core of the building, and; 3) the intersecting gables of the downriver freight rooms and boiler room. The cathedral ceiling and roof over the waiting room is supported by arch-braced hammer-beam trusses reinforced with steel tie-rods and connection plates [Fig 15.]. The trusses are pine/fir laminated with oak veneer construction. Though beautiful in their own right, these trusses are structural as well as decorative.

**Fig 15. Truss cluster supporting the waiting room cathedral ceiling.**

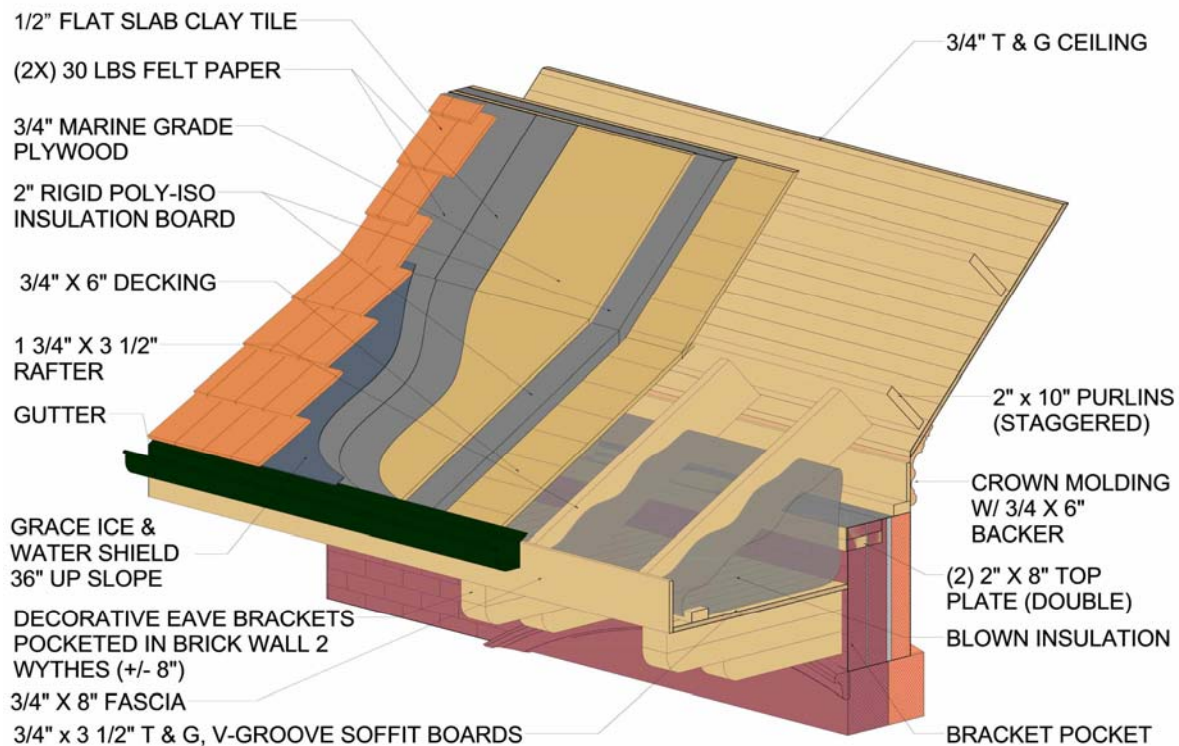
There are three slightly different eaves constructions to go with the three different roof constructions for the: 1) waiting room roof, 2) upper hip roof, and 3) downriver freight rooms and boiler room roofs [Fig 23., 24. & 25.].

Today, the soffits, fascias and rakes are in various states of decay and many sections will require complete reconstruction. Ideally, they are reconstructed in the same manner from the top-down so this work must occur in concert with the roof restoration project. It will be important to select a rot-resistant species that will perform well even though new roof details and insulation will substantially reduce the risk of ice damming, leaks and wood rot from the topside.

**Fig 23. Reconstruction details for restoring the waiting room roof eaves.**

The eaves were originally constructed from the top down, before the roof was decked and covered with clay tile. The eaves were partially reconstructed with a bead-board soffit in lieu of the original 3½" V-groove T&G soffit on the upper hip roof and along the bluffside of the downriver wing. This likely occurred in circa 1950 when the clay tile roof was removed. Recent eave repairs on the riverside were completed with T&G smooth stock and treated lumber. Specifications must be developed for higher standards to ensure that future eave repairs and restoration will incorporate V-groove T&G boards for the soffits and replicate the original wood species in every detail.

Reconstruction of the eaves will provide an opportunity to conceal electrical runs for exterior lighting and will also hide conventional HVAC gas/condensing lines until the Foundation can upgrade to new geothermal or other more energy efficient systems. The eaves should also be insulated to reduce or eliminate ice damming. Particularly around the upriver roof section over the waiting room which will be inaccessible after the new roof has been restored and the eaves reconstructed. Grace Ice & Water Shield, or similar product, should be installed at the eaves and up the roof slope to prevent water damage in the future (see details in **Appendix D**).

The reconstruction will entail new (concealed) details recommended by the structural engineer and master carpenters to strengthen the eave construction (see **Appendix D**).

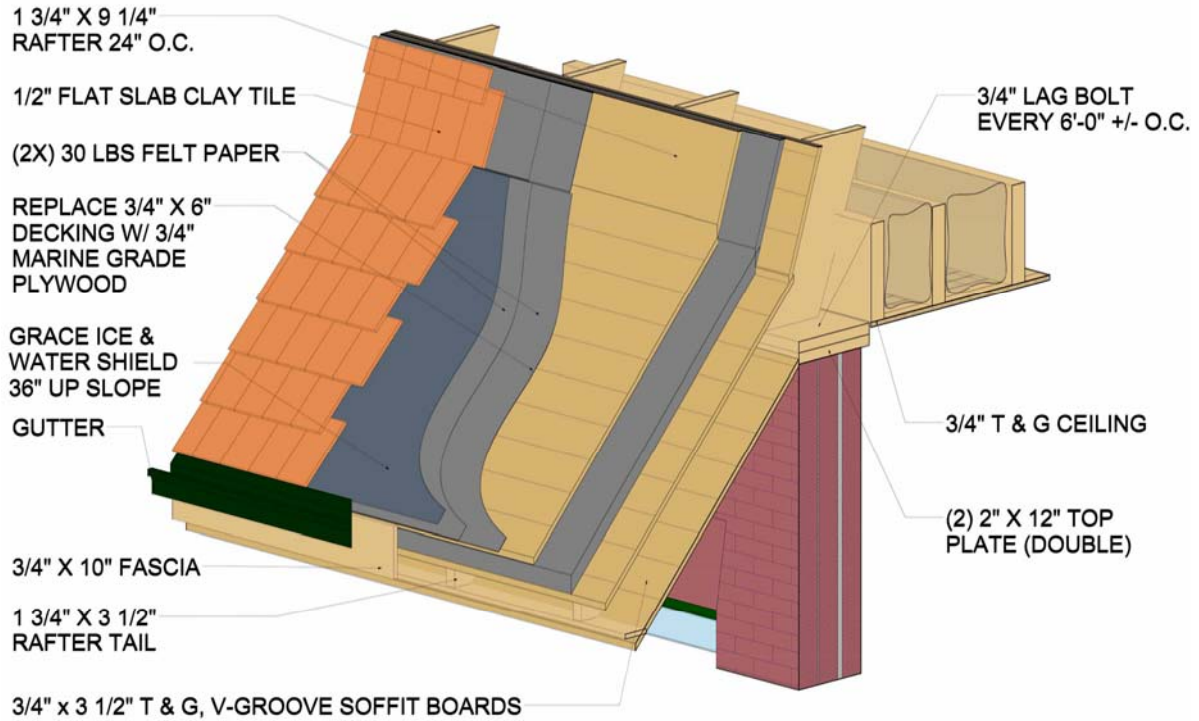
**Fig 24. Reconstruction details for restoring the upper hip roof eaves.**

The upper hip roof eave must be investigated more closely during the roof tear-off when it can be accessed from the topside to determine whether it is original from the nails, paint coatings, saw marks, etc. If original, it can likely be salvaged, stripped and restored since it is generally in better condition than the lower roof soffit. If the evidence reveals that it was entirely reconstructed during a later period, then V-groove boards to match the lower eaves should be used for the reconstruction of the upper eaves as well.

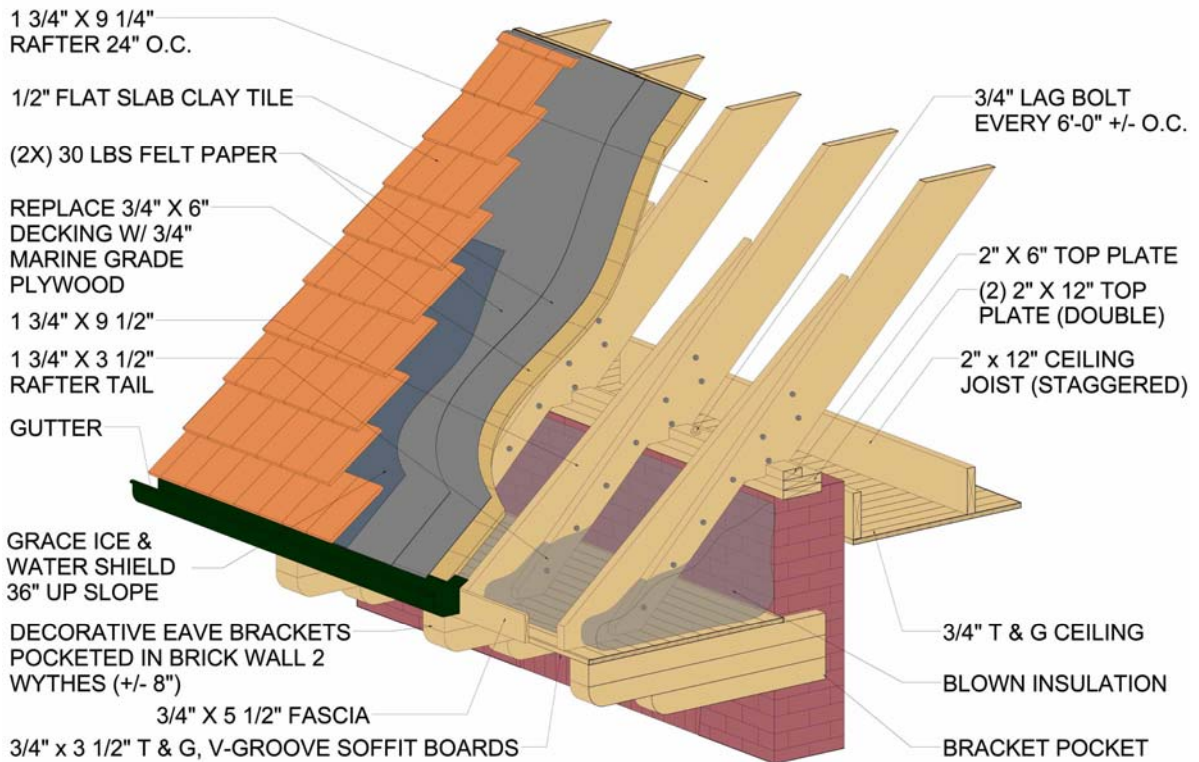
**Fig 25. Reconstruction details for restoring the freight & boiler room roof eaves.**

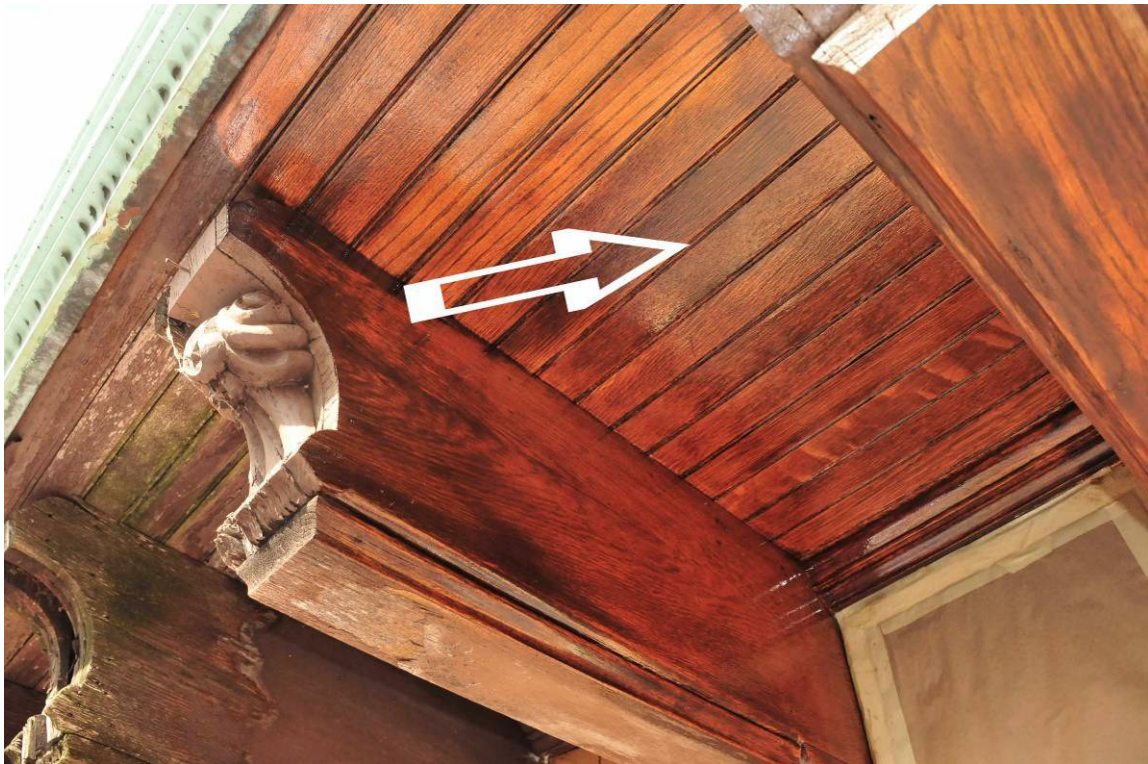
The investigation of the wood finishes for the trim color on the eaves, fascia, soffit and brackets remains inconclusive. Additional sampling will be required when the eaves are deconstructed to determine the final authentic finish. Initial samples taken in 2011 from the trackside near the waiting room revealed a natural stain and varnish; the most common wood finish applied elsewhere around the Depot. Natural finishes on the exterior trim were not uncommon for architecturally significant buildings and even private mansions of the era. A natural stain and varnish was discovered during a partial restoration of the Charles Gates Dawes mansion in Evanston, Illinois by Restoric (built just one year after the Union Depot within a few blocks from Daniel Burnham's home) [Fig 27.]. Here too, subsequent owners choose to paint the eaves over time covering the natural finishes and diminishing the historic character of the building.

**Fig 27.** Further investigation of the Depot may reveal the eaves had a natural finish as shown in this restored bay on the Dawes House (1892) a few blocks from Burnham's home in Evanston, IL.

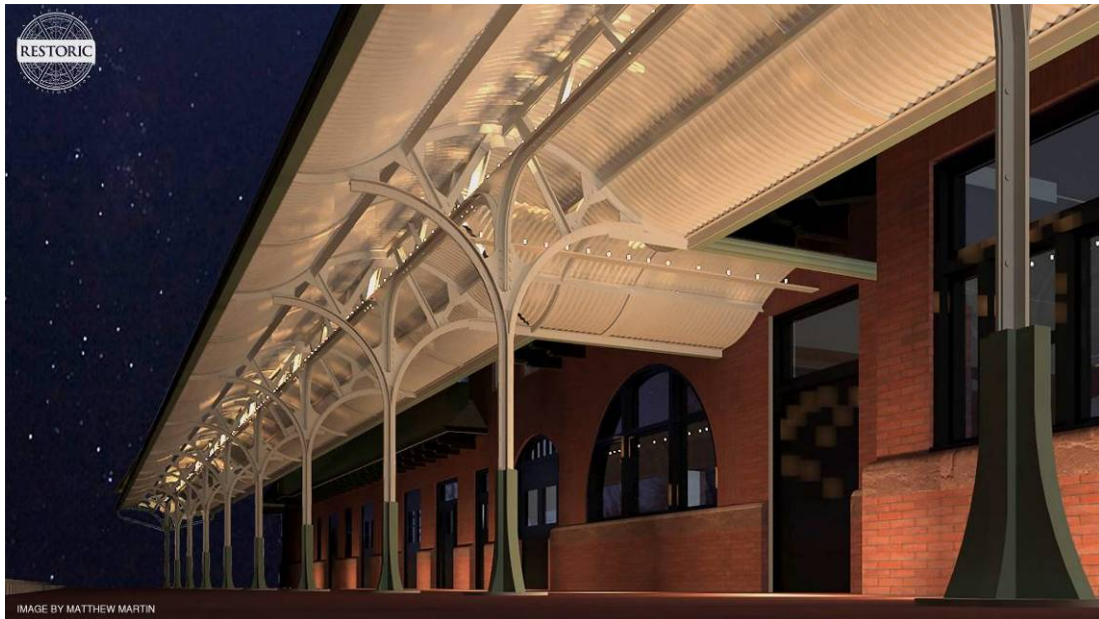
Fig 28. A 2014 rendering of the trackside canopy with restored “marquee” style strip lighting.

Historic articles seem to indicate the canopy was once fitted with “marquee” strip-style lighting; notches in the steel channels may have supported these early strip fixtures. LED lamps (bulbs) are manufactured today that mimic the warm glow of carbon filament lamps from the late 19<sup>th</sup> century. These lamps are very energy efficient and will be inexpensive to operate for extended hours. Alternate wire guards can be installed for the lamps, if vandalism proves to be an issue. A rendering was developed for the HSR to illustrate the effect this will have on the canopy and building at night [Fig 28.]. Restoring the canopy and installing new lighting may further increase public sentiment to restore the Depot.
