## INTERIOR

### Waiting Room

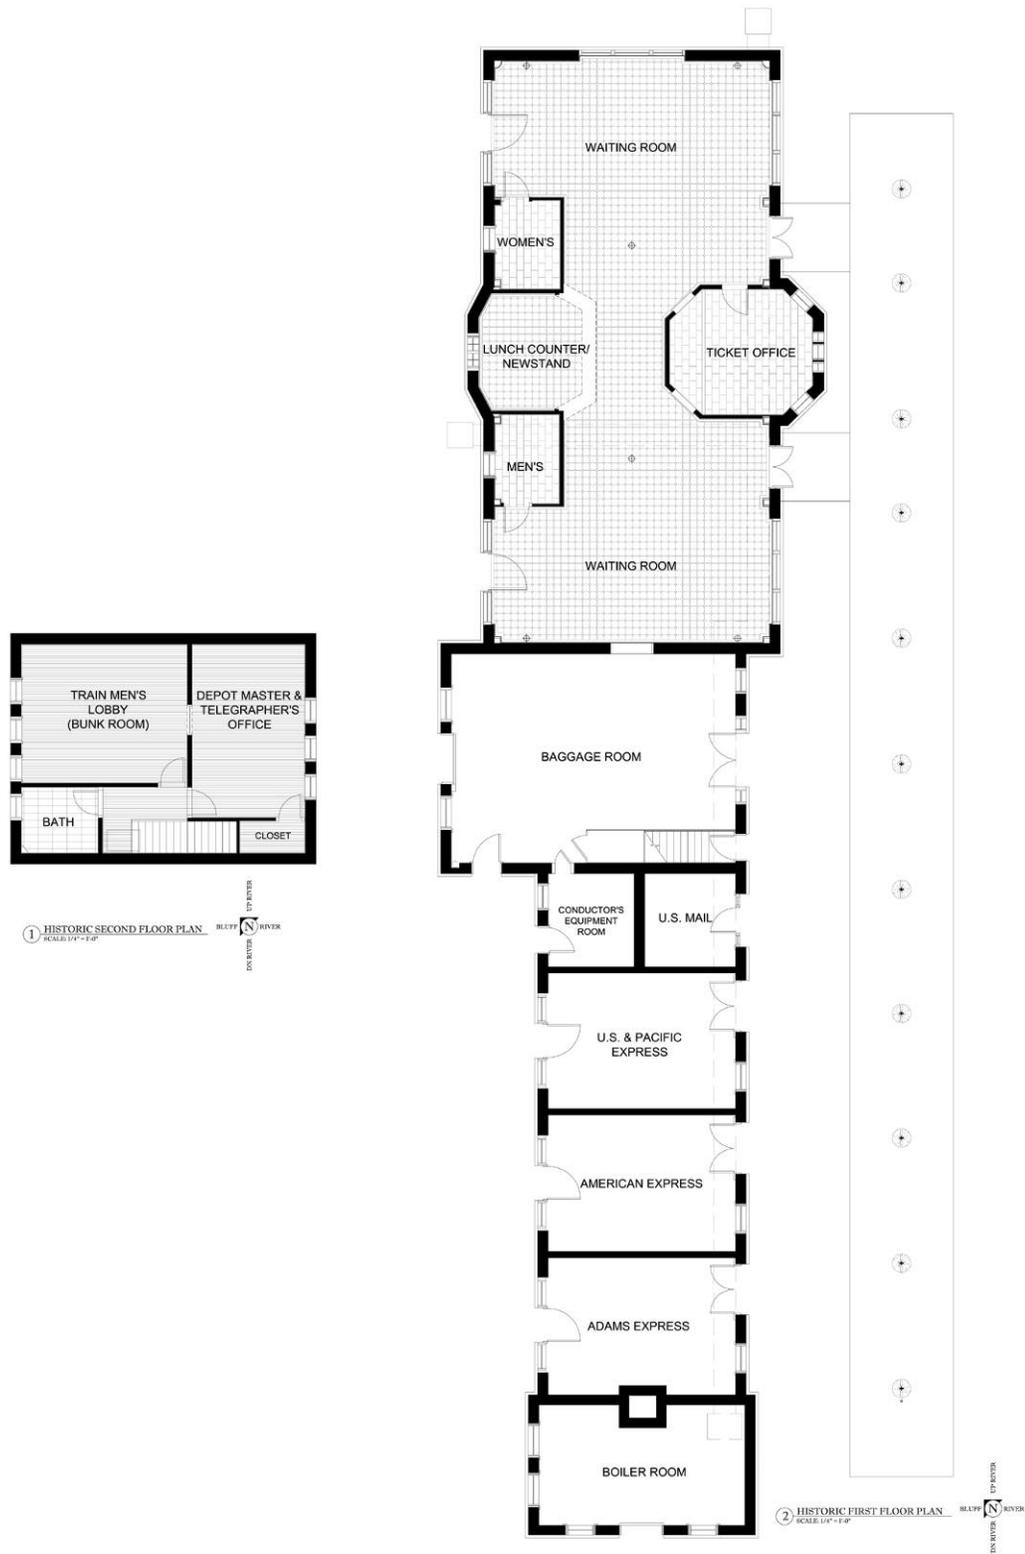
Fig 50. Original floor plan denoting original usage and floor finishes.

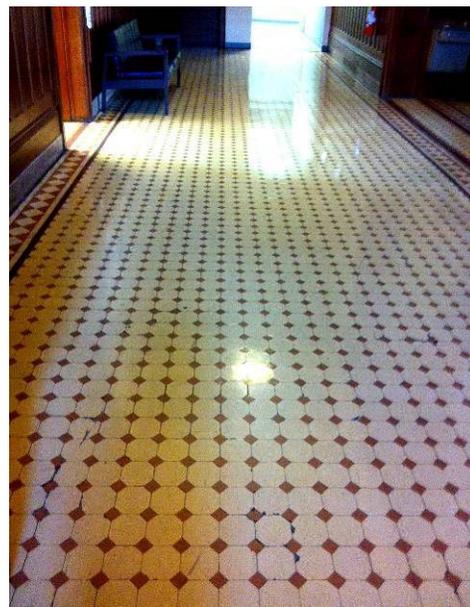
**Fig 53. A preserved floor from 1901.**

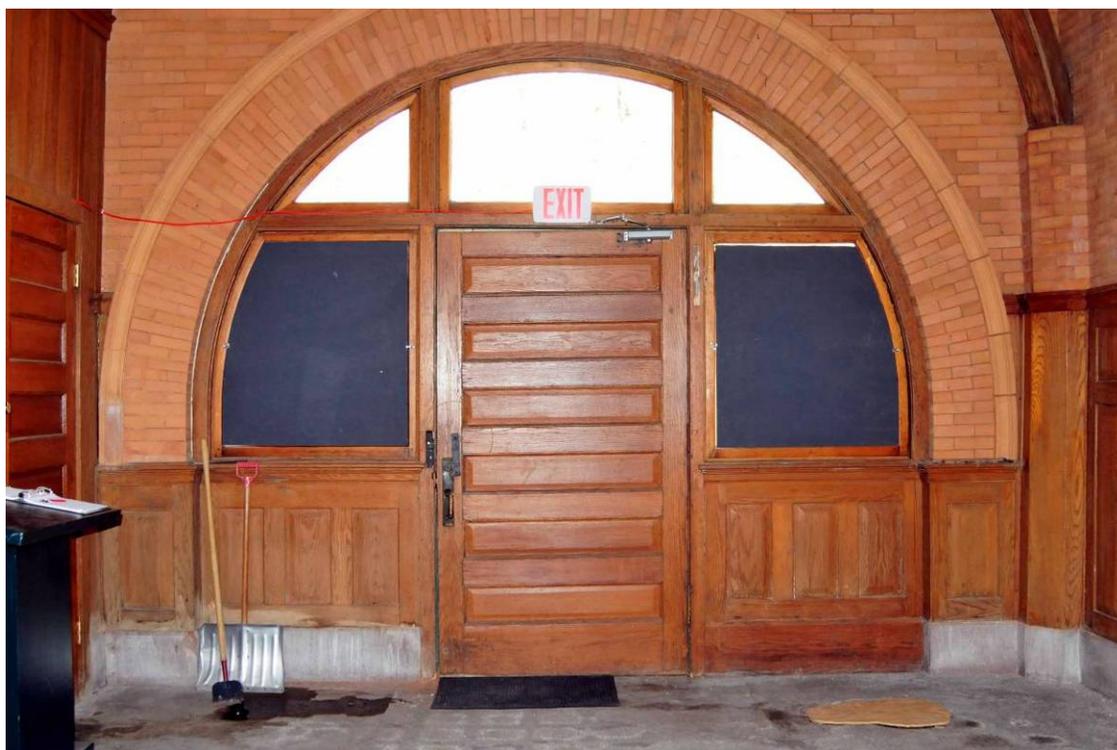
The tripartite wood window and door assemblies are set in large segmental-arch brick openings trimmed with pressed-brick headers and terra cotta lintels. The arched windows have five fixed sashes around a center-pivot ventilator, while the two north elevation assemblies incorporate wide six-panel oak doors [Fig. 54]. Flanking the ticket booth, two pairs of doors with overhead transoms lead south out of each waiting area and onto the train platform. All of the swing doors for the waiting room swung toward the tracks to aid late arrivals in their mad-dash for departing trains. The door and window casing and trim are simple, flat square stock with small stop-moldings fixing the window sashes. Original ball-tip hinges and bronze door hardware with rope-twist handles remain on many of the waiting room doors. While modern closers are installed on some doors, historic articles note that “all doors are provided with air cushions to prevent slamming.”<sup>44</sup>

**Fig 54. An arched door and window assembly on the north wall of the waiting room.**

The millwork must be de-glossed, evened out, stained and varnished. The doors and windows must be stripped and refinished; this is the one room in the entire depot where the interior of the sashes originally had a faux bois (faux grained) finish to appear as oak and harmonize with the woodwork.

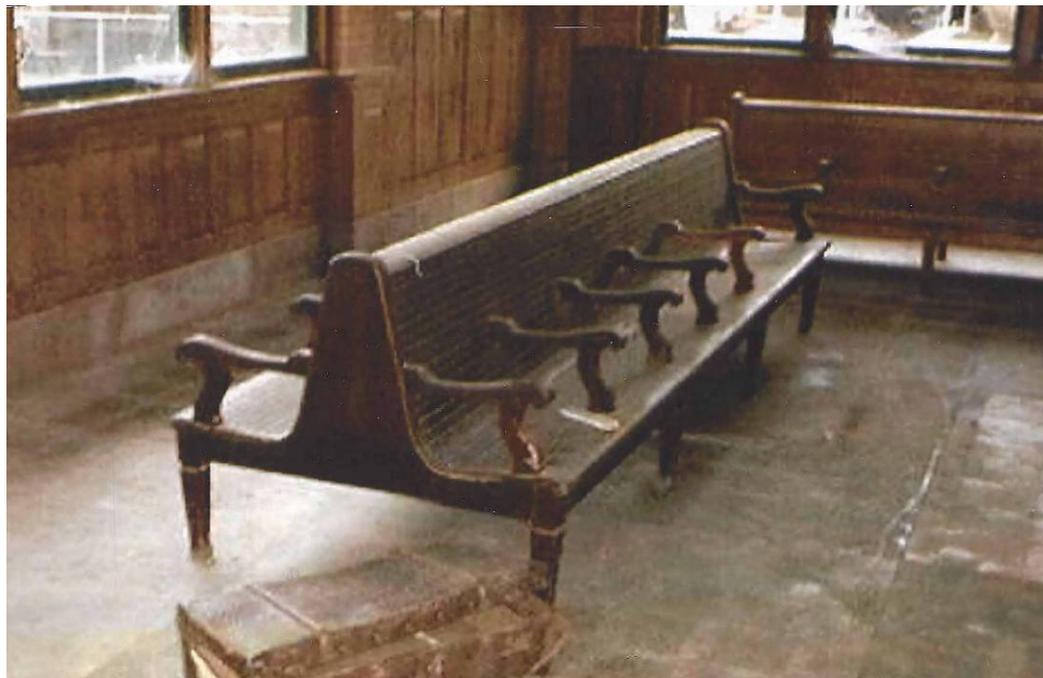
The waiting room featured "oak settees with the words 'Keokuk Union Depot' perforated in the back" as described from the grand opening. A circa 1969 historic photograph shows that some benches remained in the waiting room; although the seats and backs were painted green by that point, they were undoubtedly a natural finish originally [Fig 56].

Fig 56. Original waiting room benches (David W. Steele, 2004).

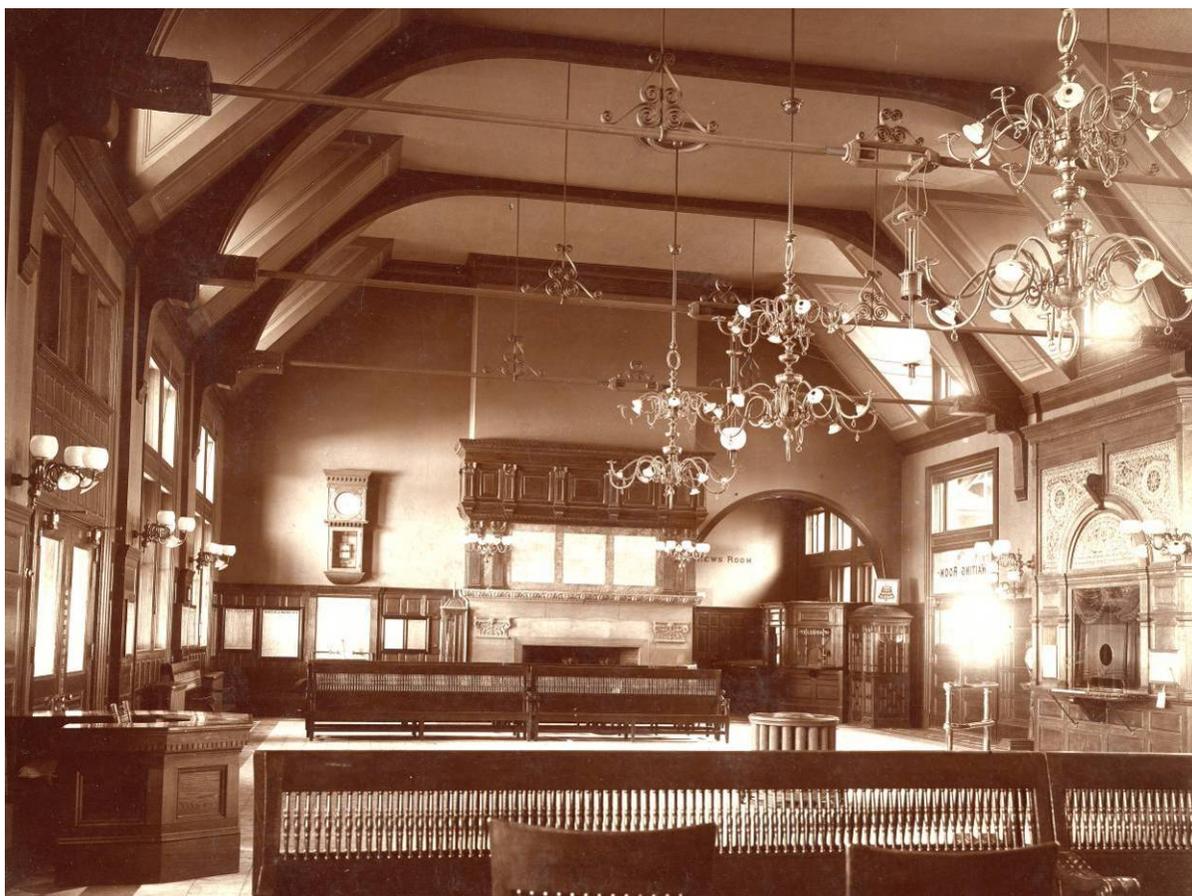
There are no known historic photographs showing the KUD waiting room interior before the circa 1949 remodeling, however, an internet search yielded historic images of the Union Station interior in Portland, Maine<sup>46</sup> built at the same time that resembles the scale and some styling aspects of the Keokuk Union Depot. Designed by the Boston firm of Van Brunt and Howe, the Portland station image below shows how a comparable depot interior of the same era was lit, finished and furnished. The exposed trusses with tie-rods, ticket office bay centered in the room, ganged benches, wainscot, steam radiators and what appears to be a marble floor, establishes an excellent historical context to guide the restoration of the Keokuk Union Depot waiting room in similar period fashion [Fig 57.]. The gas-electric combination chandeliers and sconces in particular could serve as models for the missing waiting room fixtures, if historic photos of the actual fixtures do not turn up when their design and fabrication are contracted. Restoric acquired a high-resolution image for this report that can be zoomed and enlarged to reveal the intricate details of these fixtures.

**Fig. 57. The waiting room of Portland's Union Station, Van Brunt and Howe circa 1890.**

Installing reproduction chandeliers and sconces will also have a dramatic affect on the space. If original photos of the Keokuk Union Depot interior are not found, the image of the period fixtures in the Portland, Maine station will serve as an excellent guide **[Fig 57.]**.

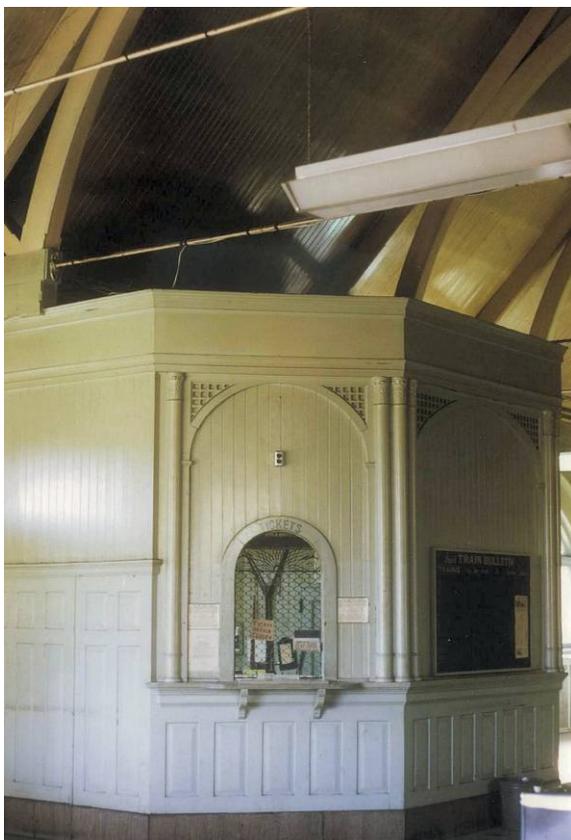
Historic photographs from the late 1960s show the original ticket office configuration with ticket windows that featured polished granite ticket exchange countertops supported by small wooden counters with decorative brackets, as well as ornamental iron window grilles [Figs 58. & 59.]. Sections of paneling have been altered, and these ticket window assemblies are long gone. However, the larger openings are still framed from counter height to cornice with clustered wood columns and latticework. The ticket office floor was slightly higher than the waiting room floor (before the terrazzo was added) and is laid with original 10" x 20" Tennessee marble tiles.

**Fig 58. Ticket office, 1969.**

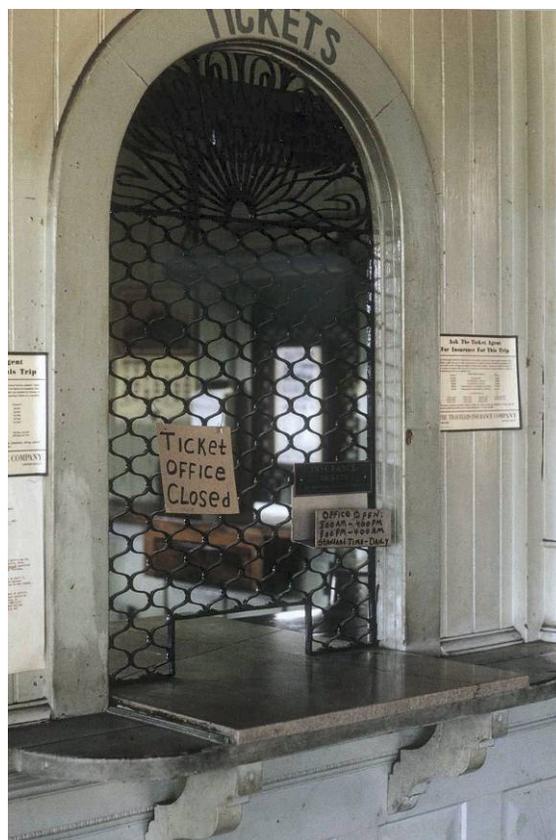
**Fig 59. Ticket window, 1969.**

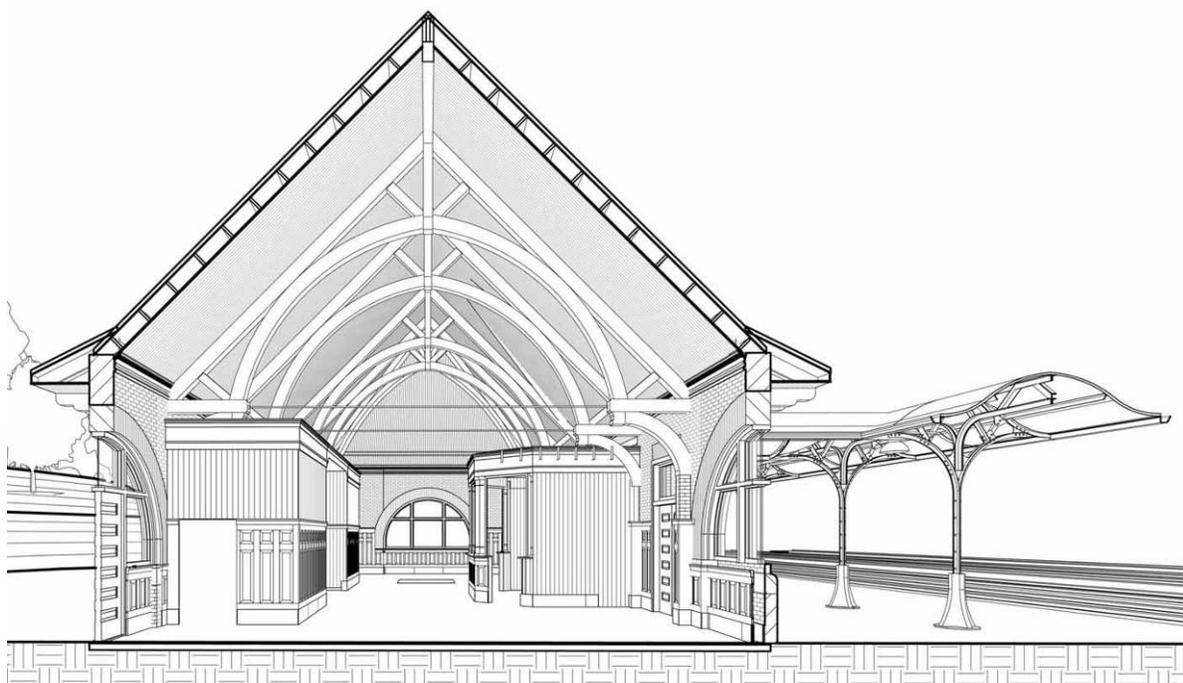
Newspaper articles note that the washrooms, labeled in the latest fashion "For Men" and "For Women" (as opposed to "Ladies" and "Gents"), were fitted with Vermont marble wash basins and partitions, nickel fixtures and "elegant" (perhaps beveled) plate glass mirrors.<sup>48</sup> While each 10'-6" x 7'-6" room remains in its original size and location, they have undergone extensive remodeling. When the lunch counter was relocated in 1949, the original washroom doors were moved to the alcove walls and toilet fixtures were removed (the original door locations were restored in 1991). These repairs also utilized salvage bead-board from the depot master's office. The washrooms have been ravaged by alterations and abuse but some vestiges remain to guide their restoration or provide design cues for reproduction washrooms to be moved downriver into the freight rooms. This would open up the waiting room for better sightlines and bigger events [Figs 60. & 61.]

**Fig 60.** Interior rendering showing original washrooms on the left (Sundquist-Martin, 2012).

No significant restoration work can occur until final plans are in place for the adaptive re-use of the waiting room—in particular, how the alcove/washroom and ticket office are deconstructed and restored respectively to meet the needs of a new public venue. The washrooms are completely inadequate; larger, accessible washrooms must be constructed downriver in the center freight rooms. This will open up the space considerably, even if the ceiling structure is suspended to hide mechanicals, provide historical reference and retain architectural interest **[Fig 61.]**. The ticket office can remain a focal point in the room and possibly accommodate a small elevated stage if the side walls are opened up more.

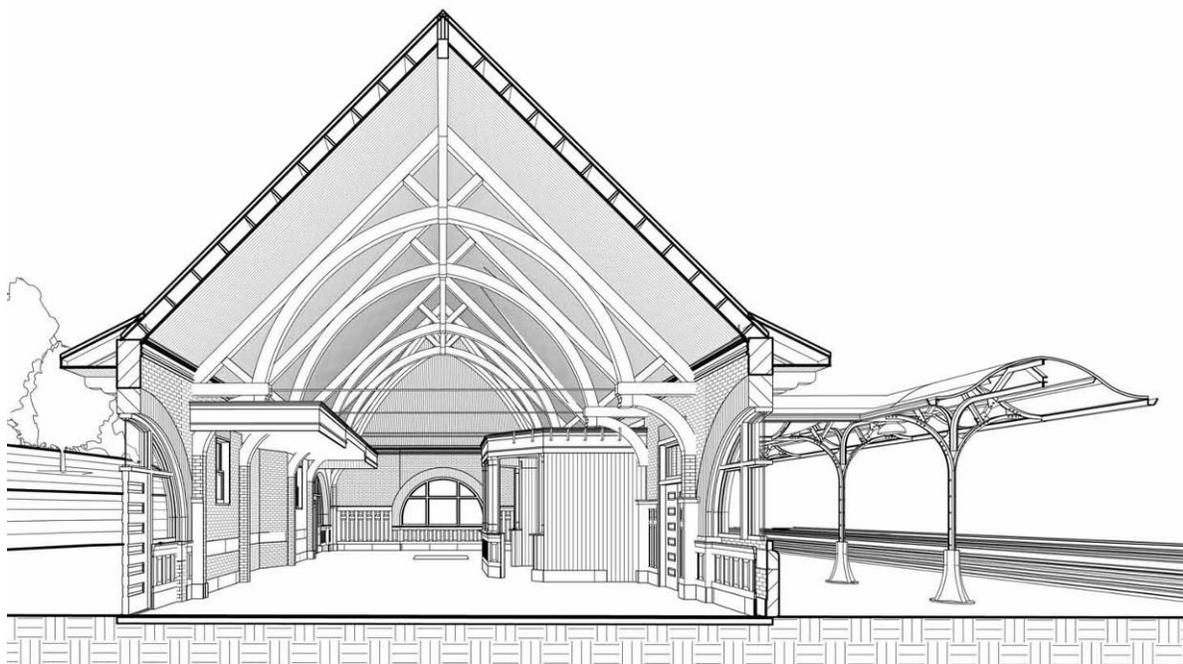
**Fig 61.** Interior view with the washrooms removed from the waiting room (Sundquist-Martin, 2012).

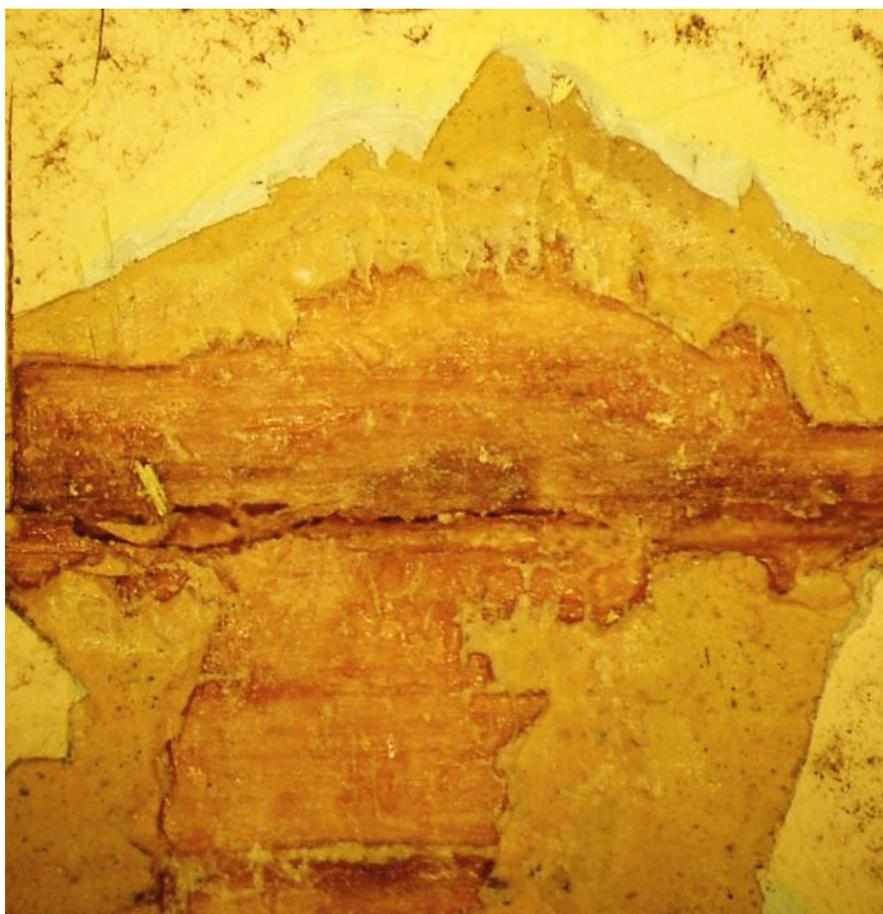
A small vestibule off the train platform is open to stairs that lead to the station employee spaces over the baggage room. The 3'-8" wide staircase, with oak bead-board walls and ceiling, ascends up worn wooden treads to the second floor. The walls have been painted with multiple coats of paint but microscopic paint analysis revealed that, here too, a clear "hard-oil" finish was originally employed [Fig 68.]. The earliest finish appears to be an oil/resin clear sealer (common varnishes from this period include gum, fossil, or oil resin). It differs from the baggage room ceiling sample in that it is a film-forming finish similar to varnish. The finish was not shellac since it was not resolvable in alcohol. The clear finish was followed by multiple paint layers, the most recent is tan.

**Fig 68. A photomicrograph of the clear finish beneath multiple paint layers from the stair paneling.**

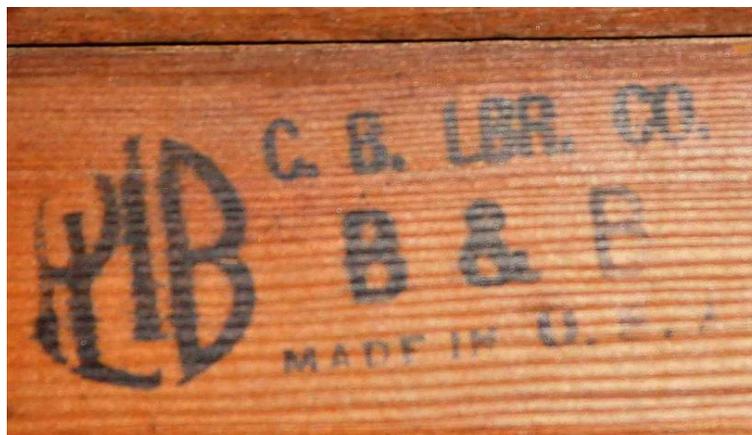
The second floor contains three rooms accessed from the upper stair landing: the depot master & telegrapher's office (office) with a closet, the train men's lobby (e.g. "bunkroom") and an employee bathroom with a shower stall. The landing, office and bunkroom have 2¼" tongue and groove oak wood flooring that was covered for many years with Masonite and, later, carpet. The ceilings are 11'-7" above the finished floor and all of the second floor walls and ceilings are also bead-board with plain stock baseboards and crown moldings. While oak bead-board was employed for the stair hall and depot master's office, pine or fir was used for the bunkroom. One piece of bead-board has a lumber stamp on the back incorporating the letters "CBL" [Fig 70.]. Research suggests that this is probably the stamp of the Council Bluffs Lumber Company which opened in 1886—a Western Iowa industry served by the same CB&Q, the major railroad backing the construction of the Depot.

Fig 70. A lumber stamp found on bead-board in the depot master's office.

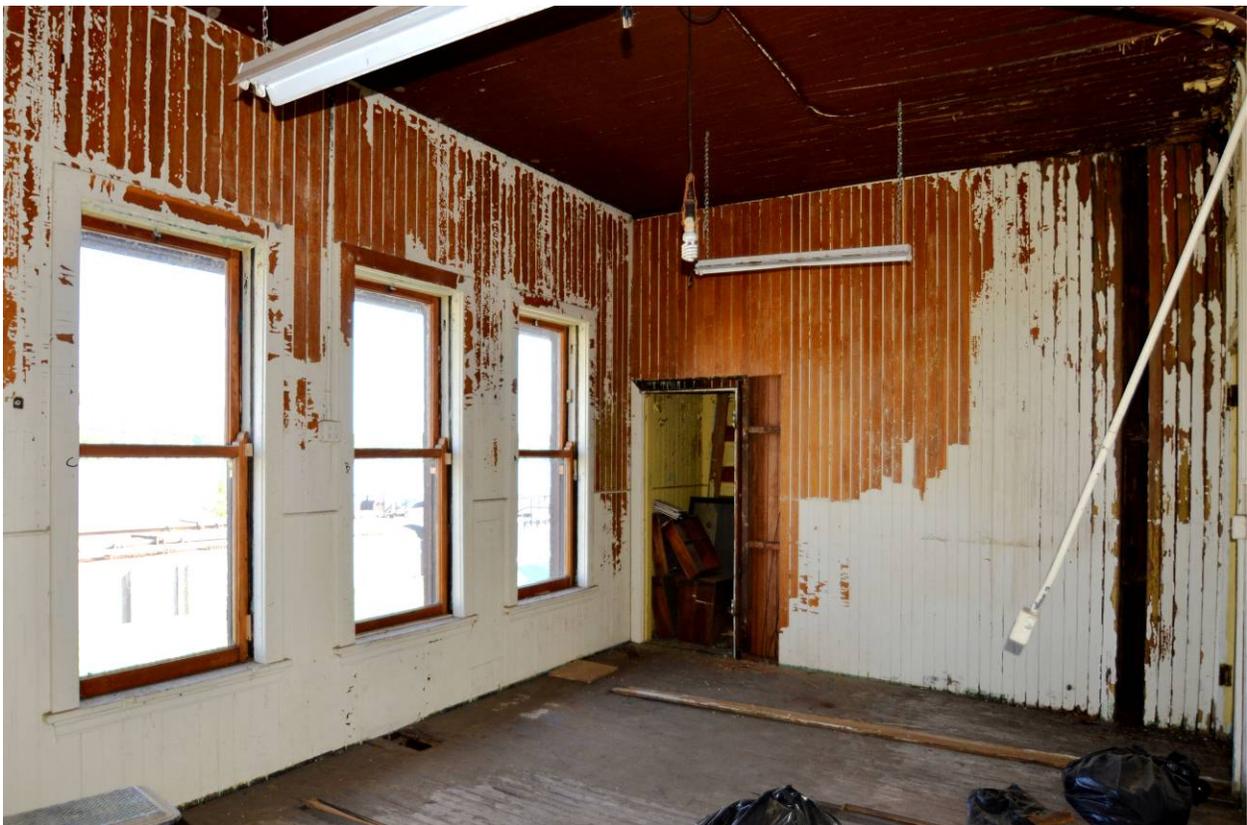
The depot master's & telegrapher's office is situated trackside on the second floor with a full view of the tracks and Mississippi River through three double-hung windows with finger lifts [Fig 71.]. A small closet is located in the southwest corner of the room. Multiple wires entered the depot master's 13' x 20' office—once the hub of station management—which required the attention of two operators.<sup>55</sup> Many holes remain on the trackside wall that once led to telegraph poles and the semaphore (i.e. order board) signaling trains, reminders of the critical communications between operators and engineers to control the many arrivals and departures of multiple railroads during the heyday of passenger and freight traffic. A hollow metal call tube is found in the northeast corner of the room. According to former KJR employee, Keith Courtney, this tube was routed to the ticket office to allow direct communication between the ticket agent and train order operator.

**Fig 71. The depot master's office overlooking the tracks and Mississippi River (May 2014).**

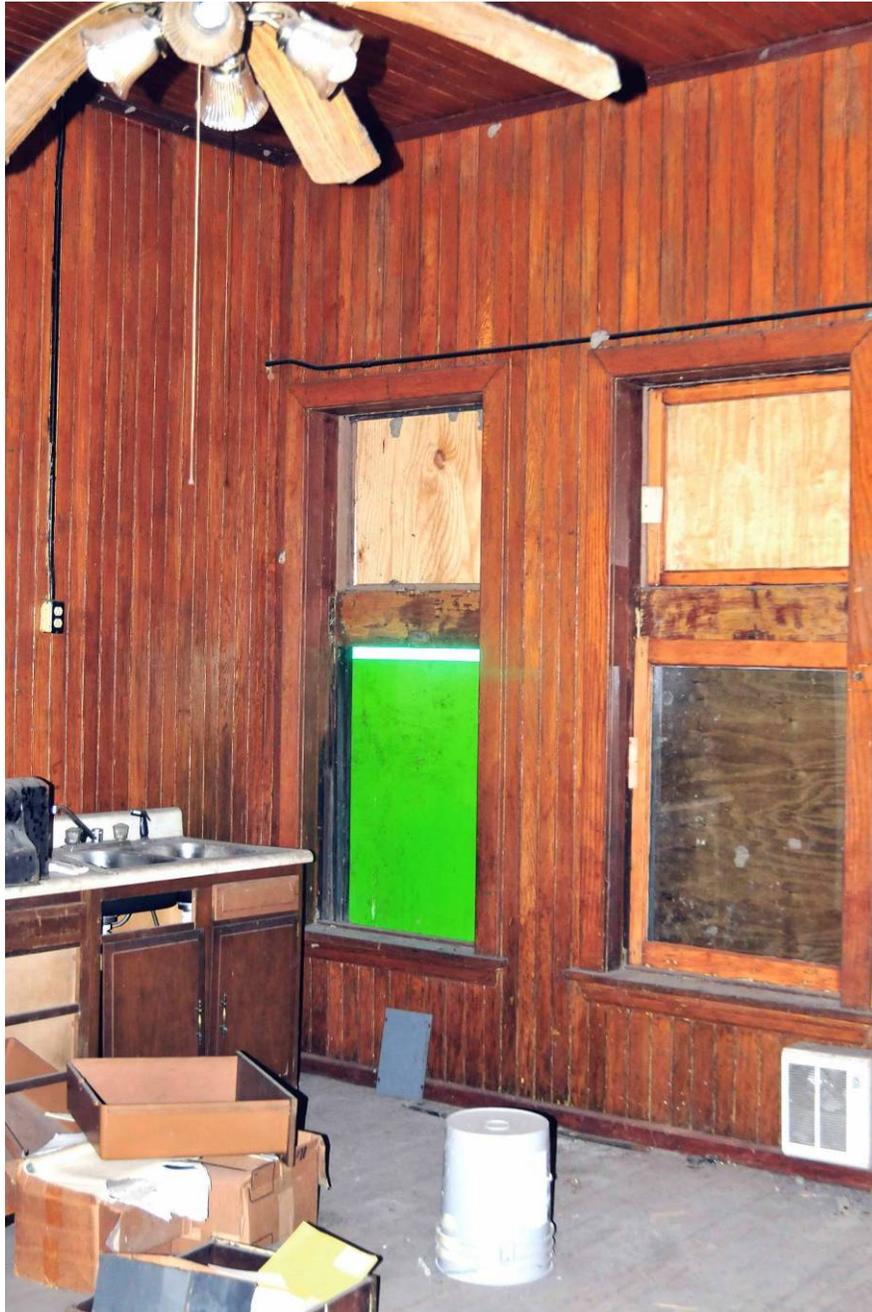
The adjacent 16' x 19' bunkroom was "handsomely furnished" when the Depot opened. It was later used as an apartment, and a kitchenette was installed on the downriver wall [Fig 72.]. An electric wall heater was also added after the steam heat for the building was abandoned. In the shared wall between the office and the bunkroom, there was once a large arched window which may have had obscured glass.<sup>56</sup> The window was removed and this opening has since been covered. Three single-hung "slip-head" windows with fixed transoms face the bluff. All walls and the ceiling are covered with bead-board along with a wood floor which imparts a rustic cabin feel to the room. The bunkroom is currently unused and there are no immediate adaptive reuse plans to occupy this space or utilize it for historical interpretation. This space retains a lot of historic integrity.

**Fig 72.** The bunkroom was used in the 1970s for living accommodations.

plays or other events held in the waiting room. The walls and ceiling should be washed, deglossed, re-stained and varnished. The floor should be restored or replaced as discussed previously in conjunction with the depot master's office. Here too, the windows could be restored with triple glazed sashes or interior storms to reduce the industrial sounds of the riverfront. Depending on the final location of the stairs, and how that impacts the bathroom doorway, a new door may need to be cut into the downriver wall to access the bathroom directly from this room.
