MASONRY

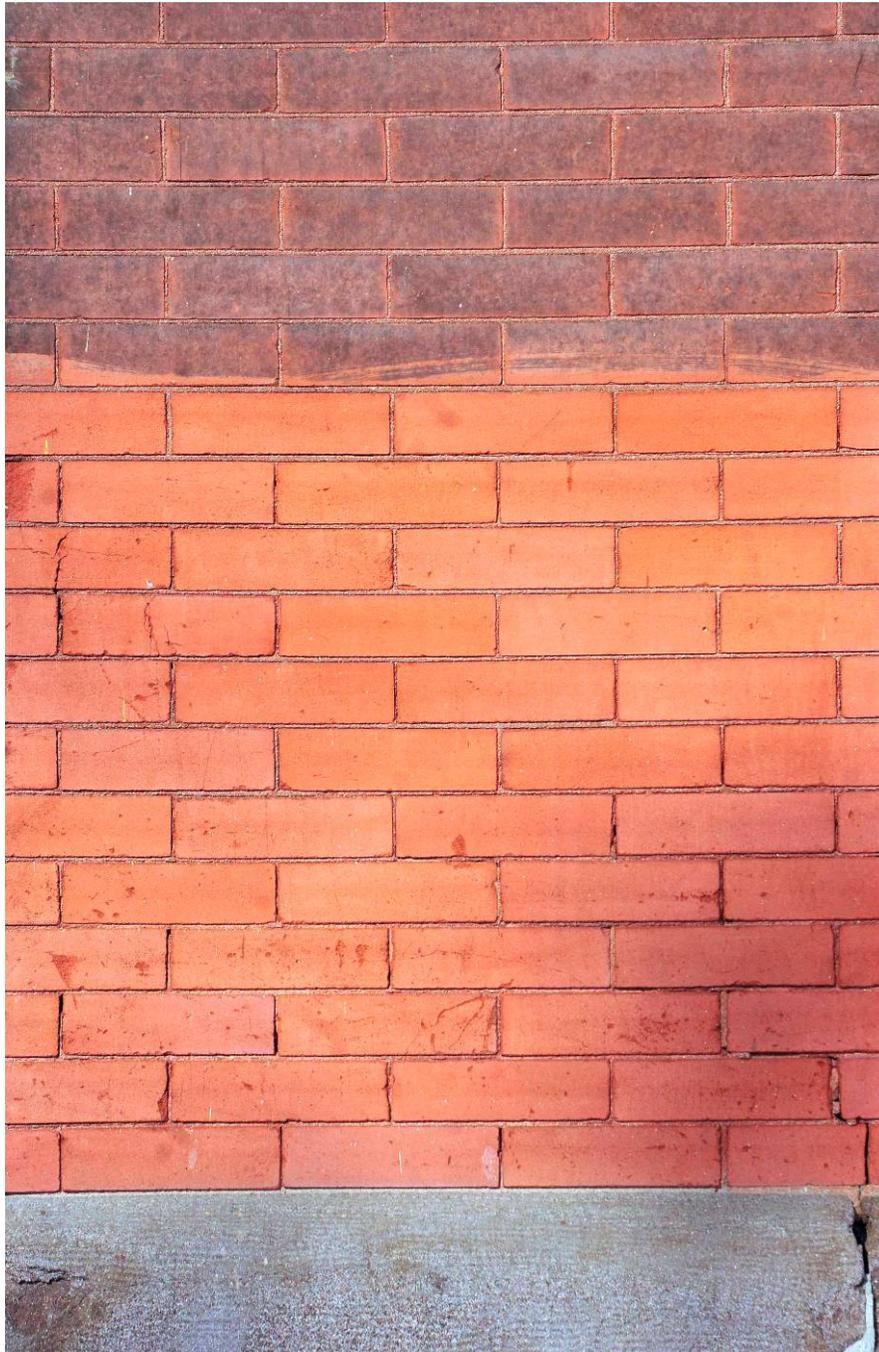
The red face brick (i.e. pressed brick) veneer used on the exterior of the Depot does not have any maker's marks and the origin of this brick has not been identified either. It is a high-quality brick that has performed well in the elements and also likely came from an Illinois or Chicago distributor (even if manufactured elsewhere). The brick is laid-up with thin butter-joints in running bond in a rose-pigmented mortar that was very popular during the "brown decades." The original color of the brick was much more vibrant than the dark patina acquired over the past 123 years [Fig 35].

Fig 35. Partial cleaning of the exterior brick.

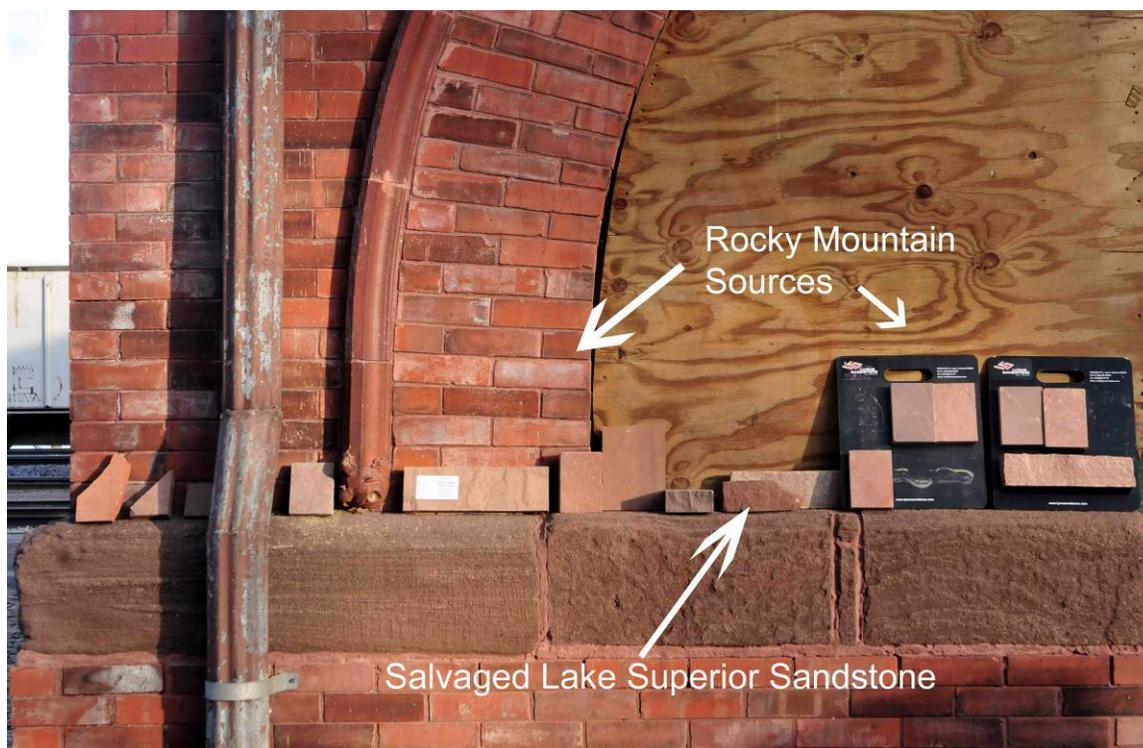
Geologists and masons from Colorado, Illinois, Michigan and Wisconsin have been contacted in an effort to positively identify the stone. Moreover, stone samples from Rocky Mountain stone distributors and salvaged Lake Superior stone samples have been compared to stone on the Depot; of these, the Lake Superior sample was the closest [Fig 43.]. Stone samples from the Keokuk Depot were removed and compared to several buildings in Colorado reportedly constructed with Peachblow sandstone to verify a match without success. The physical evidence indicates the stone used for the Depot was either a gross anomaly of the Peachblow quarry, or was an undocumented change during construction by the mason or builder. Burnham & Root may have specified Peachblow, but if quarry, fabrication, or delivery problems arose during construction, Carbondale was the closest source to Keokuk. A stone sample from the Depot was compared to the sandstone walls of Christ Episcopal Church (1888) in Waukegan, Illinois which has documented Wolf’s Carbondale brownstone. This comparison proved to be the best match to date [Fig 44.]. The high mica content in the Depot stone is also a characteristic of Carbondale brownstone.⁴⁰

Fig 43. Initial comparison of sandstone samples from Colorado and Michigan in 2012.

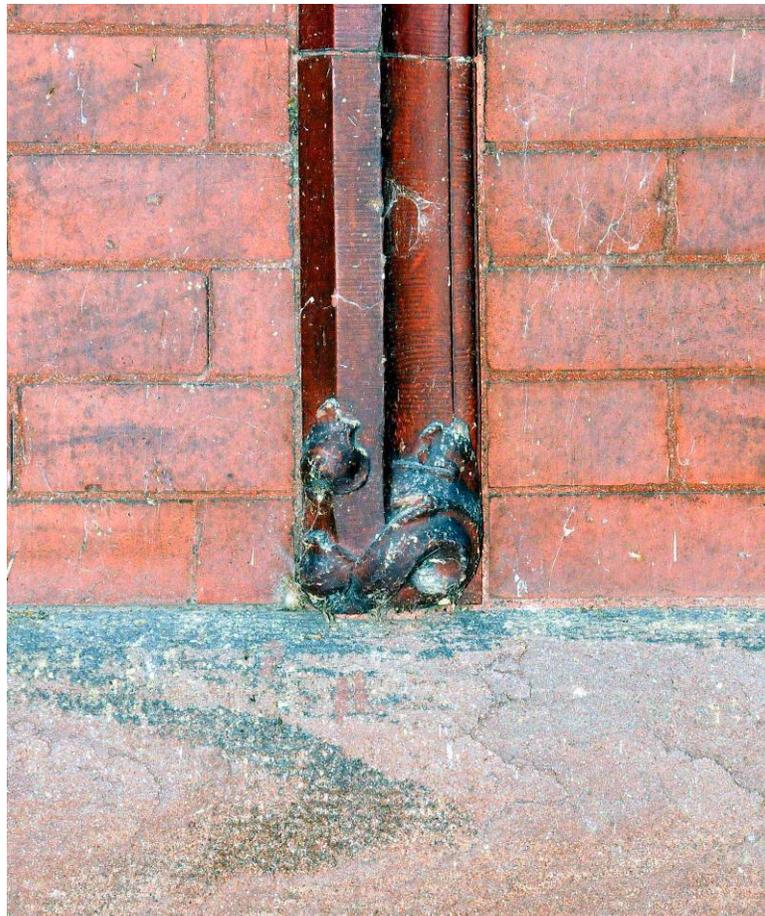
The exterior terra cotta lintels are found at all of the large arched windows and doorways around the Depot. They are thin-glazed reddish-brown in different profile from the interior lintels and terminate with a restrained foliage detail [Fig 46.]. These lintels also appear to closely match the hue and value of the adjacent brick; once both materials are properly cleaned a more pronounced, but intentional, color shift may be revealed to accent their presence. The vast majority of these pieces are in excellent condition requiring cleaning only. However, a few pieces have been damaged by overly aggressive cleaning or replaced with poor matches [Fig 47.]. These pieces should be replaced with a closer match when the masonry is restored.

Fig 46. Terra cotta foliage detail on exterior.

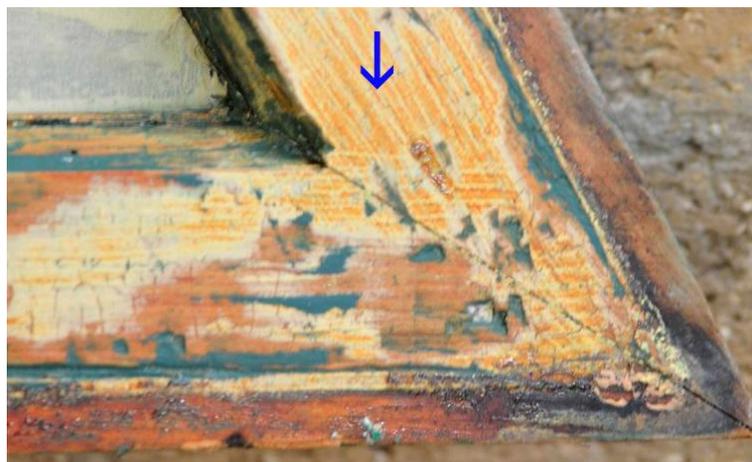
Fig 48. Original Faux bois finish on waiting room Windows.
